# M.L. "Bob" Emiliani

## PEER-REVIEWED PAPERS

## THE EFFECT OF MICROSTRUCTURE ON THE EROSION OF Ti-6Al-4V BY SPHERICAL PARTICLES AT 90° IMPACT ANGLES

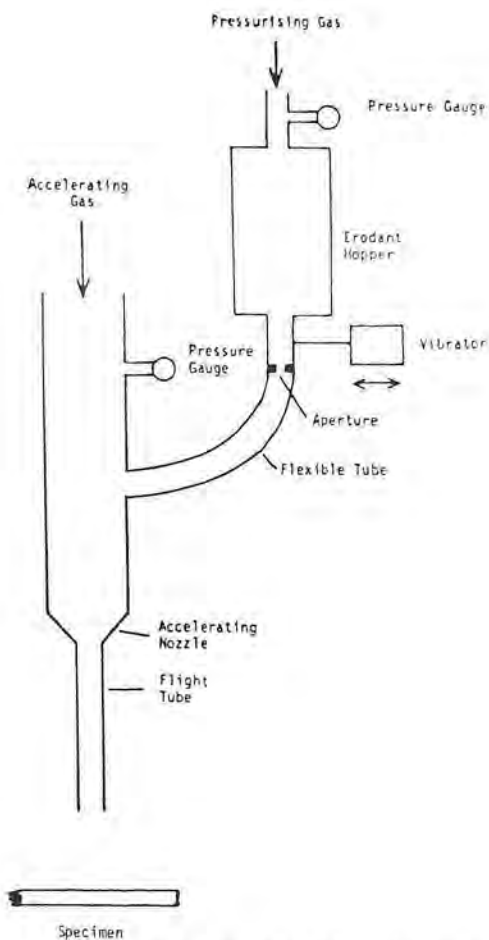
Fig. 4. Schematic diagram of the erosion test equipment.

Erosion was performed at room temperature in a gas-blast rig. A schematic diagram of the apparatus is shown in Fig. 4. The particle velocity was calibrated by the double-disc technique [23]. To avoid humidity effects from compressed air and to provide a non-oxidizing atmosphere nitrogen was used as the accelerating gas to obtain a particle velocity of  $61\ \text{m s}^{-1}$  ( $\pm 7.5\%$ ) at an impingement angle of  $90^\circ$ .  $90^\circ$  impact is the least understood erosion condition. The erodent concentration was maintained at  $1.0\ \text{g cm}^{-2}\ \text{s}^{-1}$ . Targets were weighed after specific periods of erosion to determine the mass change. The erosion rates were expressed in terms of mass change per unit area as a function of the concentration of erodent.

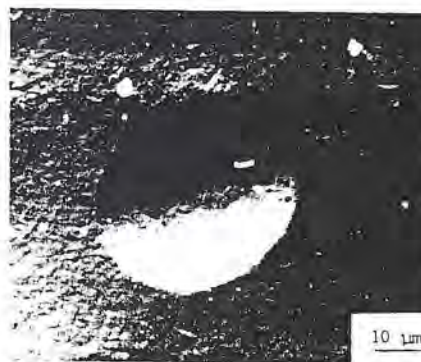
Fig. 5. Single-impact crater on the equiaxed  $\alpha + \beta$  structure. Only craters mirroring the erodent were found.

A single-impact crater on an equiaxed  $\alpha + \beta$  target is shown in Fig. 5. No lips were found around craters for single impacts normal to the target. Instead there was only a slightly raised area around the crater periphery. This is consistent with earlier work on weaker and more ductile targets in surface conditions ranging from electropolished to ground, where a "threshold" number of impacts prior to material loss was reported [10, 4].

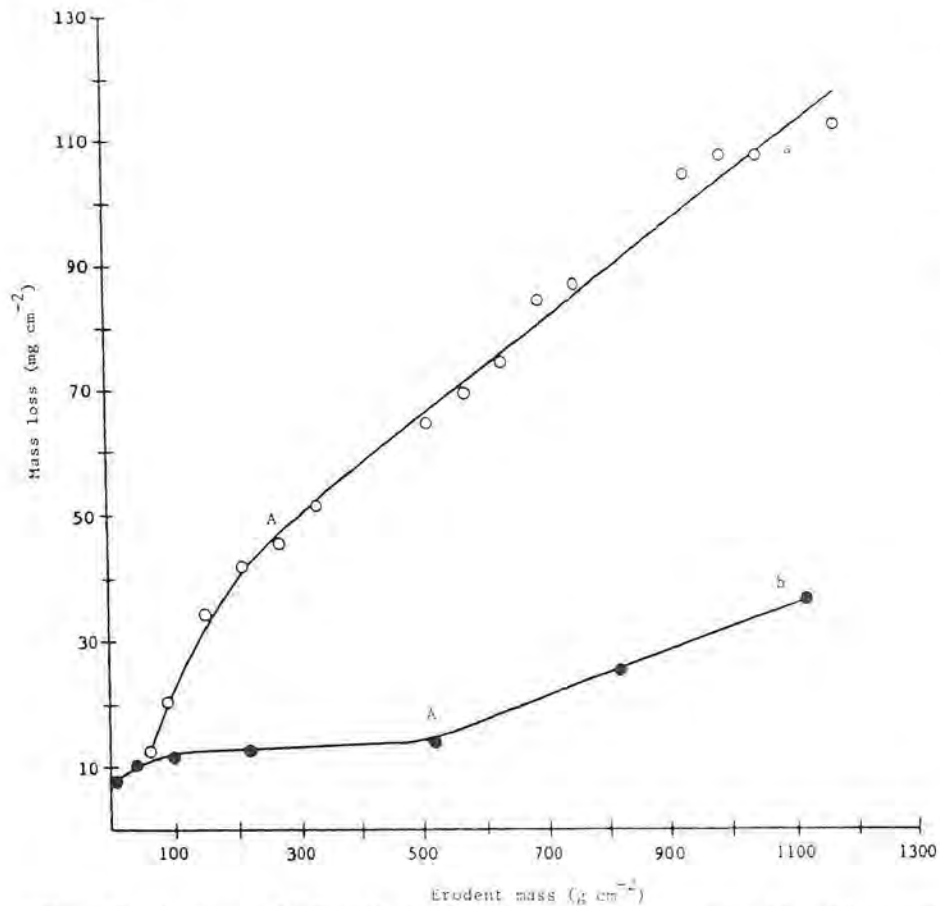
Fig. 6. Erosion curves for Ti-6Al-4V (210  $\mu\text{m}$  silica spheres; velocity, 61  $\text{m s}^{-1}$ ; loading rate, 1  $\text{g cm}^{-1} \text{s}^{-1}$ ; impingement angle,  $90^\circ$ ): curve a, equiaxed  $\alpha + \beta$  structure; curve b, basketweave  $\alpha + \beta$  structure.

The erosion curve (Fig. 6) details the behavior of Ti-6Al-4V in the equiaxed  $\alpha + \beta$  condition. For ductile targets such as aluminum, iron and copper, a continually increasing erosion rate from the start of erosion preceded a constant steady state of material loss [5, 8, 10]. For the equiaxed

The erosion curve for the basketweave structure is included in Fig. 6. An incubation period of decreasing rate of material loss was found. However, the initial material loss rate for the basketweave structure in this region was greater than for equiaxed  $\alpha + \beta$  targets but for a much shorter period of erosion. After incubation there was a region of near-zero material loss preceding a constant steady state erosion period. As for equiaxed  $\alpha + \beta$  targets, and contrary to that found for softer targets, the erosion rate in the steady state was lower than in incubation. The steady state erosion rate for equiaxed  $\alpha + \beta$  and basketweave targets is given by the slope of the curves beyond A in Fig. 6. Equiaxed  $\alpha + \beta$  targets had an erosion rate of 0.074 mg of material removed per g of erodent impacted, while the erosion rate of basketweave targets (0.038 mg g<sup>-1</sup>) was nearly half that of equiaxed targets.

The departure from incubation to steady state erosion was characterized differently for the two microstructures and as shown in Fig. 6. The equiaxed  $\alpha + \beta$  structure exhibited one change in slope, while the basketweave structure showed two changes in slope. The difference is believed to be due to the characteristics of the glass layer for each microstructure, namely the layer thickness and the surface area covered by it.

Figure 6 suggested that the increased ductility associated with the equiaxed  $\alpha + \beta$  structure increased the steady state erosion rate under the present test conditions. This contrasts with earlier work [29] where it was found that increased ductility reduced erosion rates. However, the target materials used were Cu-4%Al and steel. A different erodent was also used. Clearly different mechanisms are at work when titanium is eroded with spherical glass beads. It is probable that the conclusions arrived at previously are indeed correct for soft targets with high thermal conductivities.

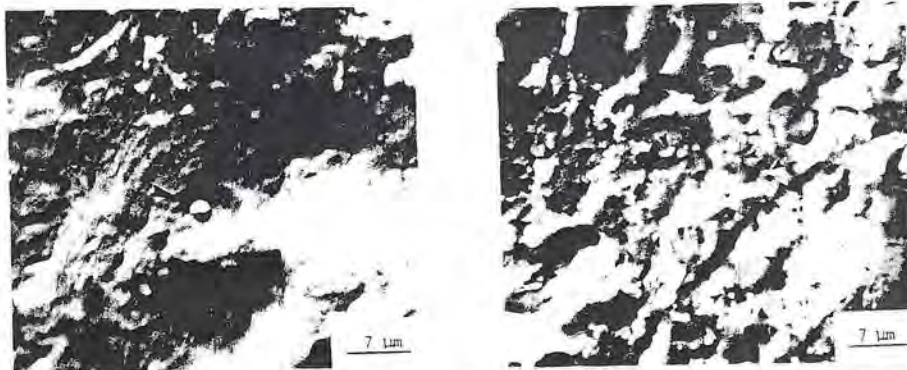
Fig. 9. The arrowed droplet, approximately  $2 \mu\text{m}$  in diameter, has been shown by EDS to be titanium.

Two different forms of evidence for melting were found in equiaxed  $\alpha + \beta$  targets. Figure 9 shows an individual spherical droplet (arrowed) lying on the target surface, while Fig. 10 shows numerous small spheres lying on

Some evidence for melting was found in the form of single droplets 2  $\mu\text{m}$  in diameter upon the eroded surface, and shown in Fig. 9, or alternatively a series of droplets about 0.5  $\mu\text{m}$  in diameter lying upon and embedded within the glass on the target surface (Fig. 10). Both types of melting morphology have been previously observed but on much lower melting point materials. Direct melting of the surface with the ejection of drops from the molten pool produced similar individual drops in two low melting point materials [30].

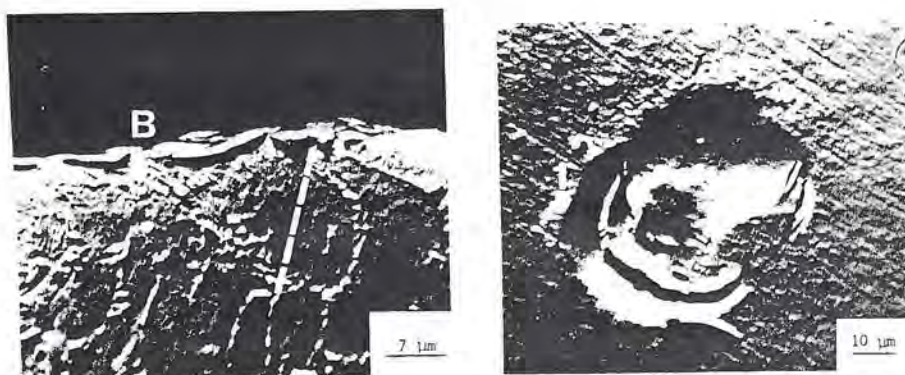
Fig. 11. Metallographic section of the steady state eroded equiaxed  $\alpha + \beta$  structure showing a discontinuous layer of glass on the surface. A region of plastic deformation to a depth of  $6 \mu\text{m}$  below the surface was evident from the movement of the  $\beta$  phase.

Examination of metallographic sections of steady state targets showed a layer of glass on the target surface  $1 - 2 \mu\text{m}$  thick (Fig. 11). The layer exhibited no evidence of brittle fracture but was discontinuous over the target surface. This permitted metal to be exposed to erodent (Fig. 11, B). Below the glass, plastic deformation of the metallic substrate was indicated by the movement of  $\beta$  particles from their aligned rolling direction position,

as shown by the broken line in Fig. 11. The deformed layer was restricted to  $5 - 6 \mu\text{m}$  below the surface for the erosion conditions used.

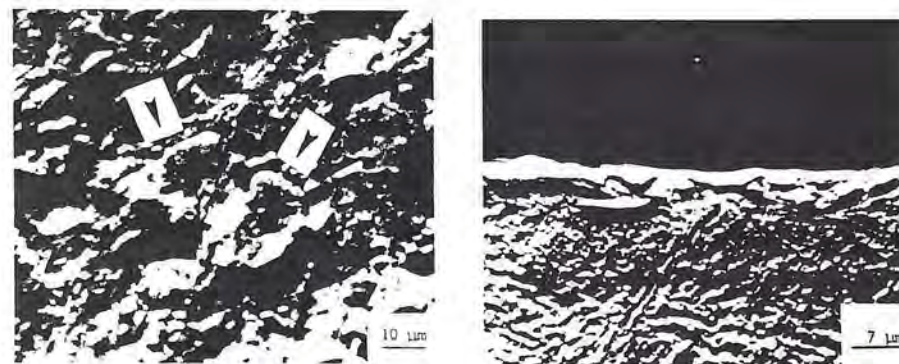
Fig. 13. Steady state eroded surface appearance of the basketweave structure target. A small platelet was found on the surface, and it was of similar size to that found in incubation.

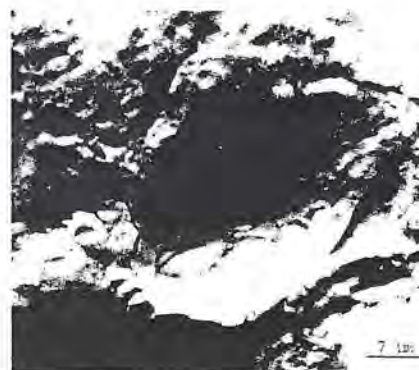
Fig. 17. The lip of glass formed by impact at less than 90° indicates that the glass is able to undergo significant plastic flow and hence to absorb impact energy.

25  $\mu\text{m}$  in diameter embedded in the surface of an equiaxed  $\alpha + \beta$  target. Further evidence of plastic deformation of erodent is shown in Fig. 17. The smooth glass layer was impacted by a silica sphere, and a lip formed typical of ductile metal impact. X-ray EDS analysis confirmed that the lip and most of the crater was glass.

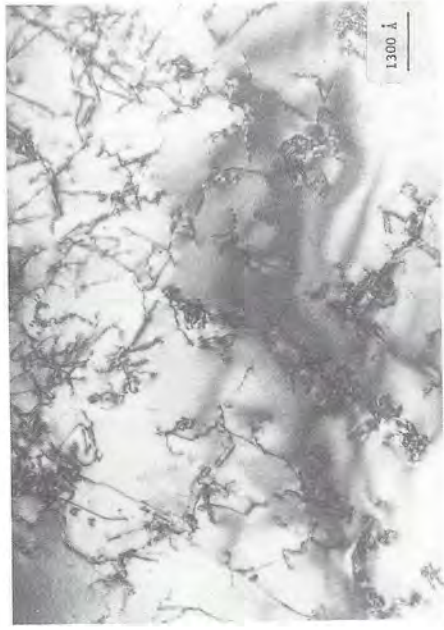
Fig. 1. Bulk Inconel 617: (a) transmission electron micrograph showing uniform arrays of straight dislocations and carbide particles; (b) EDAX spectrum (copper is an artifact); (c) X-ray diffraction pattern (Cu K $\alpha$  radiation,  $\lambda = 1.54 \text{ \AA}$ ); (d) electron diffraction pattern showing a  $[001]$  zone axis.

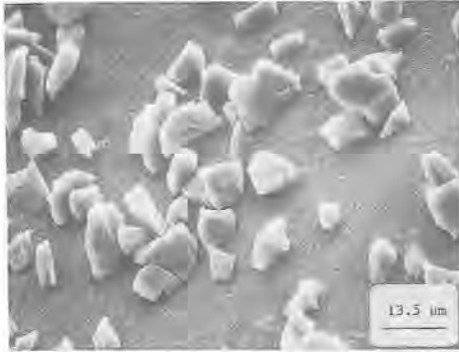
Fig. 2. Scanning electron micrograph of SiC erodent: note the range of particle sizes and shapes; 45° tilt.

[13]. Samples were briefly eroded at 90° using angular 15  $\mu\text{m}$  SiC (Fig. 2) at a velocity of 67  $\text{m s}^{-1}$ .

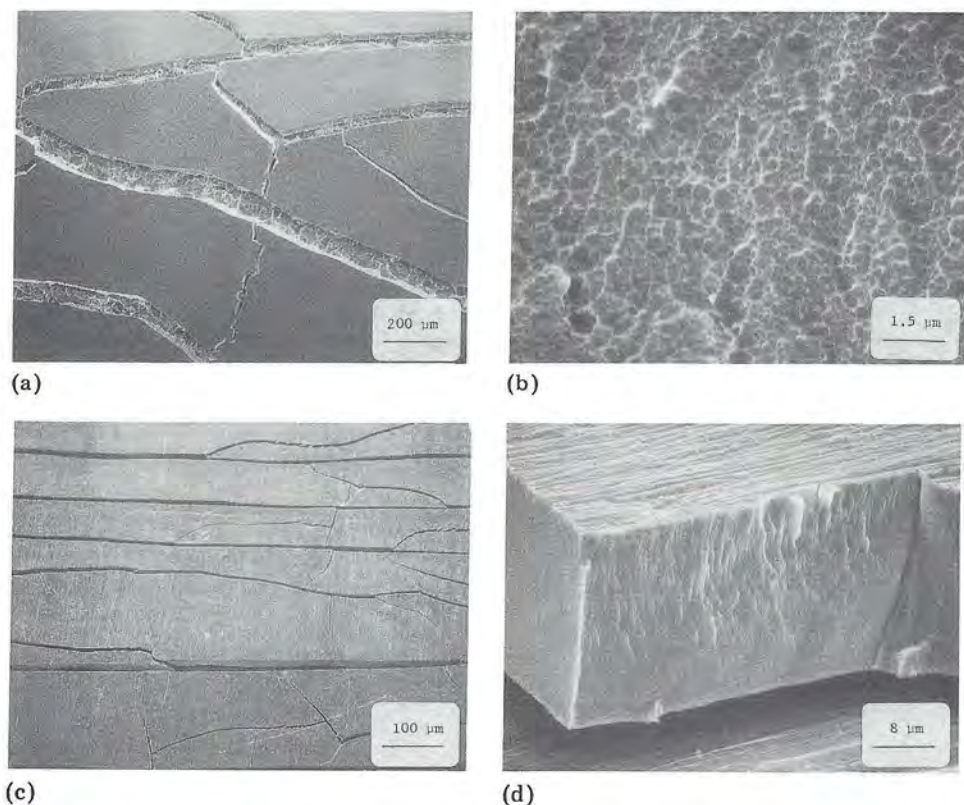
Fig. 3. Fracture morphology of sputtered Inconel 617 and reactively sputtered Inconel 617 nitride: (a) scanning electron micrograph of 180° bend test of sputtered Inconel 617 on c.p. titanium; (b) dimples on fracture surface; (c) 180° bend test of reactively sputtered Inconel 617 nitride on c.p. titanium; (d) fracture surface showing brittle fracture and densely packed fibrous columnar structure.

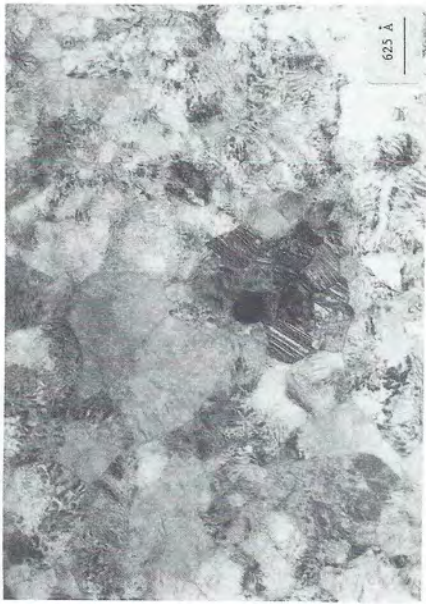
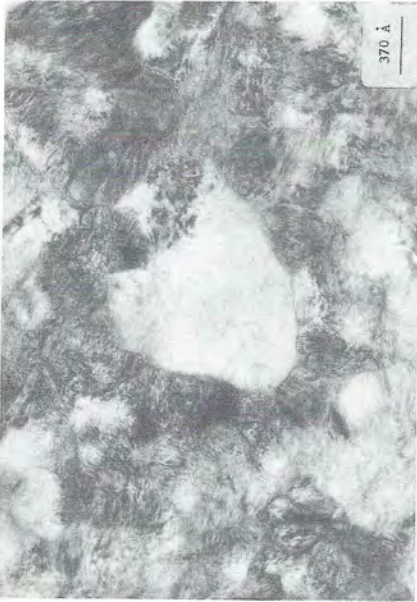
Fig. 6. Sputtered Inconel 617: (a) and (b) transmission electron micrographs of sputtered Inconel 617; (c) 5  $\mu\text{m}$  selected area diffraction pattern showing a b.c.c. structure; (d) microdiffraction patterns of the large central grain in (b) with a  $[111]$  zone axis.

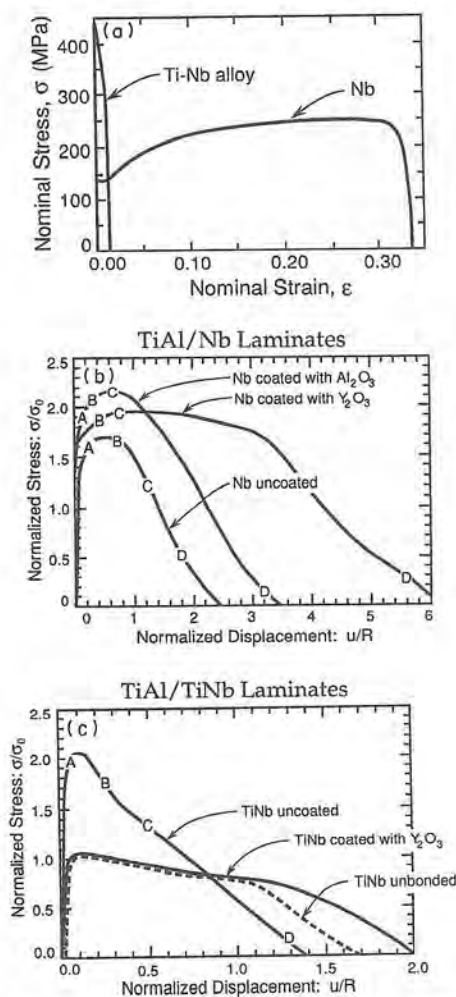
Fig. 5. (a) Tensile stress/strain curve for the unbonded reinforcements (the specimen gauge length was 10 mm). (b) Tensile stress/stretch curves for the TiAl/Nb laminates. The letters refer to the points on the curve that correspond with the *in situ* SEM pictures shown in Fig. 6. (c) Same as (b) but for the TiAl/TiNb laminates.

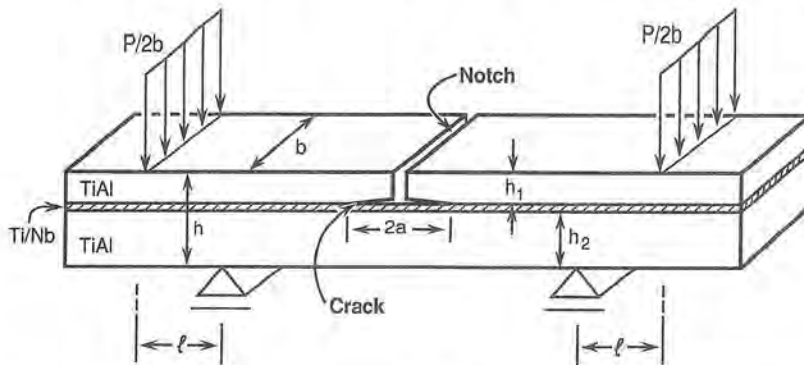
Fig. 10. A schematic of the test specimen used to measure the interface fracture energy.

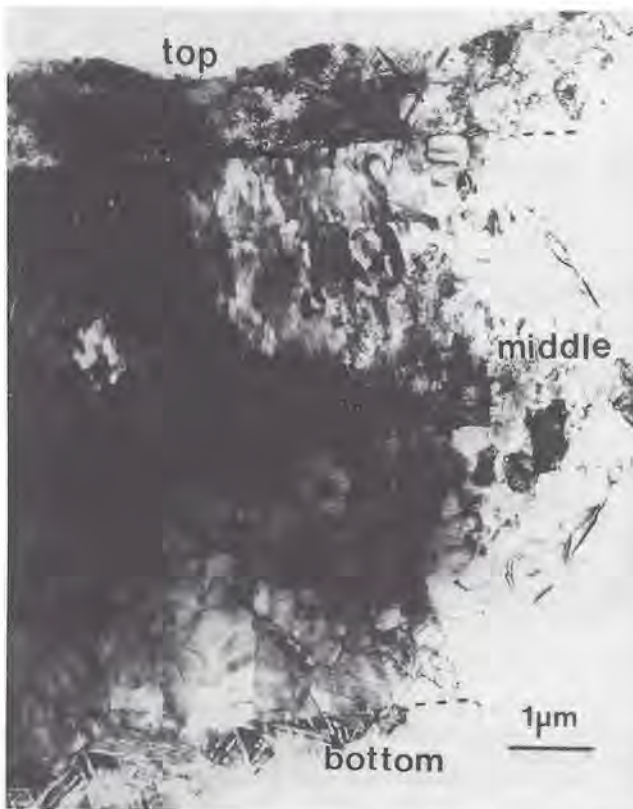
Fig. 3—Cross-sectional TEM micrograph of sputtered INCONEL 617 (top), intermediate phases (middle), and titanium martensite (bottom).

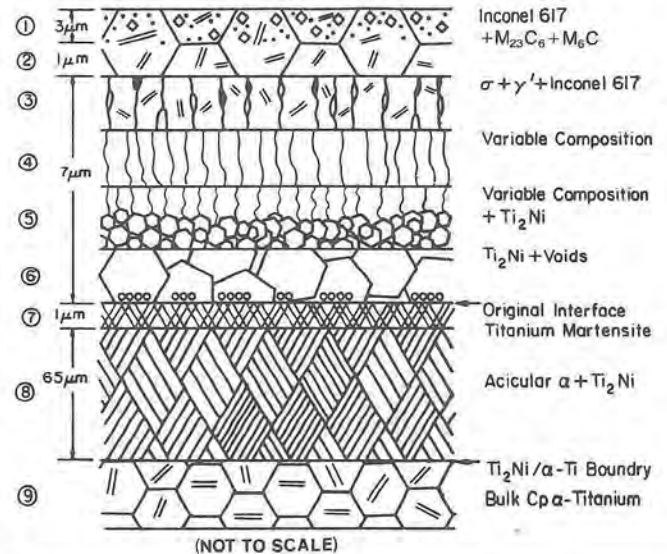
Fig. 4—Schematic diagram showing all phases and layers present in the coating and substrate after heat treatment at 800 °C for 2 h. Layers 2 through 7 are shown in Fig. 3.

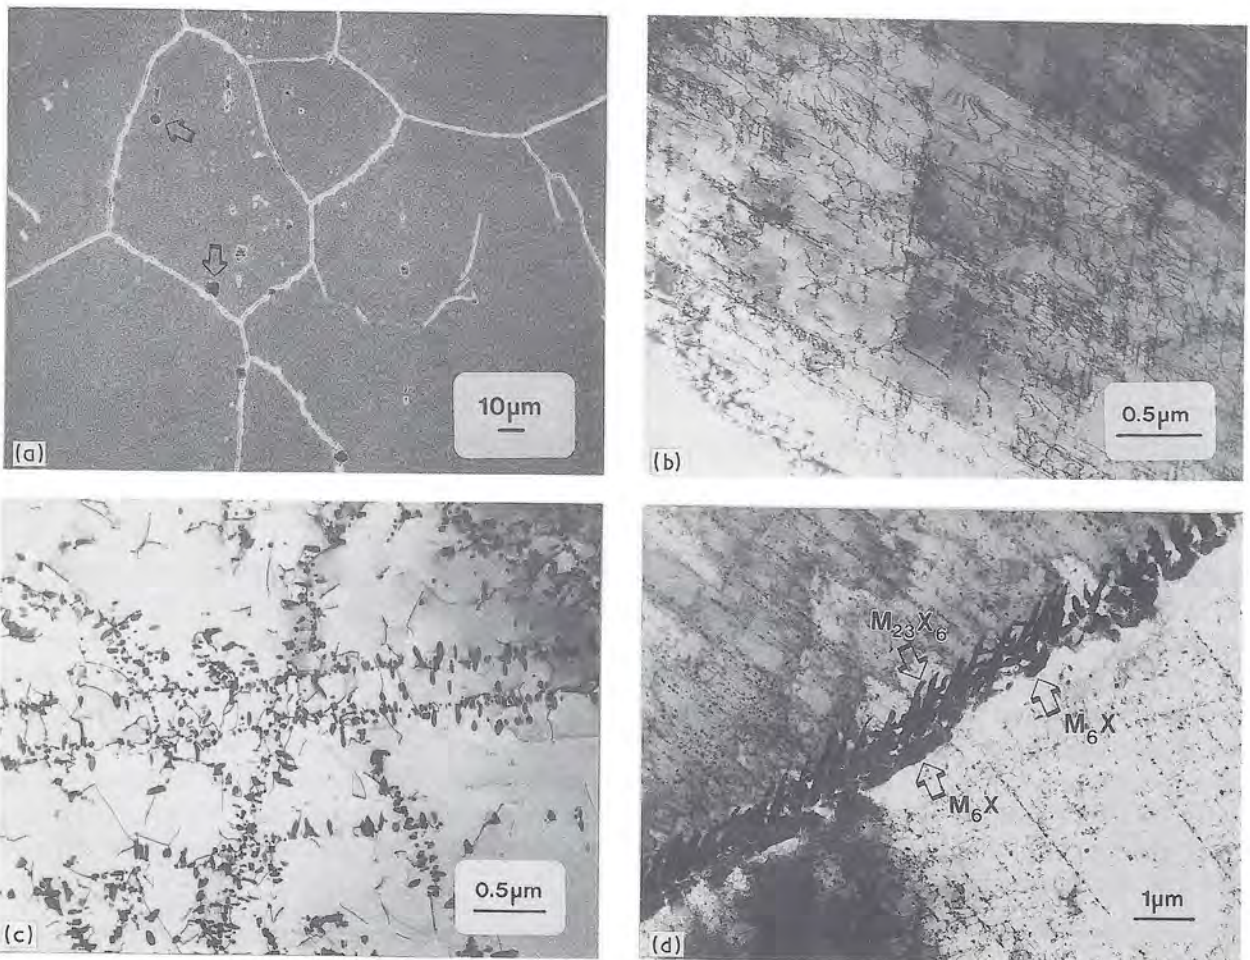
Figure 1 (a) Scanning electron micrograph of cold-rolled and solution-annealed Inconel 617 in the as-received condition showing grain boundary and intragranular carbide (arrows). Etched in glycergia. (b) Dislocations in the  $\gamma$  phase of as-received Inconel 617. (c) Intragranular  $M_{23}C_6$  nucleated upon slip lines and dislocations after heat treatment at  $800^\circ\text{C}$  for 200 h. (d)  $M_6C$  nucleated on grain boundary  $M_{23}C_6$  (arrows). Note the extensive precipitation of intragranular  $M_{23}C_6$ .

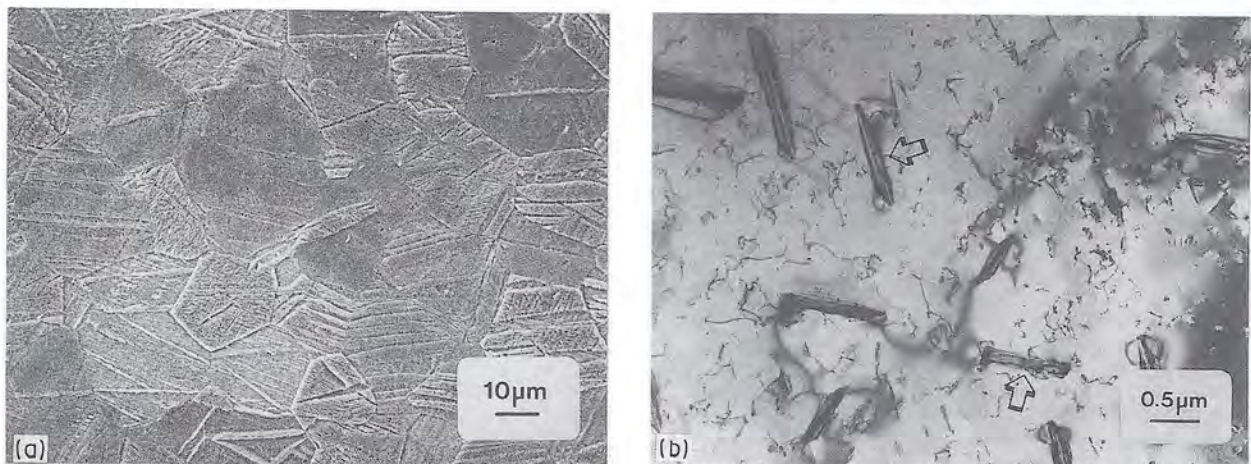
Figure 2 (a) Scanning electron micrograph of commercially pure  $\alpha$ -titanium showing small equiaxed grains, twins, and titanium hydride precipitates (Etched in Kroll's solution). (b) Transmission electron micrograph of titanium hydride needles (arrows).

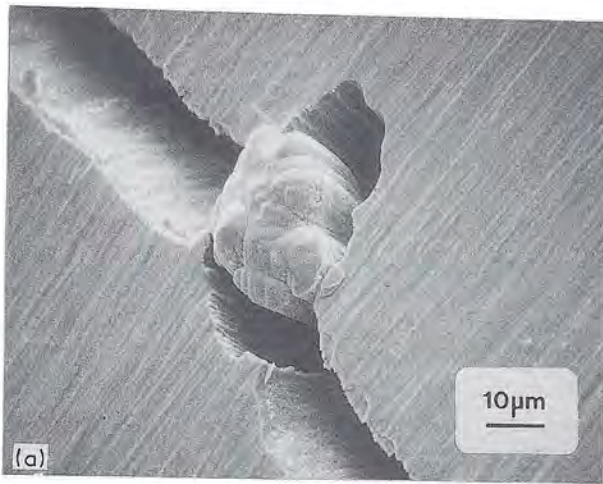
Figure 3 (a) Scanning electron micrograph of a nodular growth defect in sputtered Inconel 617 deposited on to ground  $\alpha$ -titanium. Note that the coating has fractured around the growth defect in this bend test sample. (b) Scanning electron micrograph of a nodular growth defect in sputtered Inconel 617 deposited on to polished  $\alpha$ -titanium. Note the smooth surface finish around the nodule.

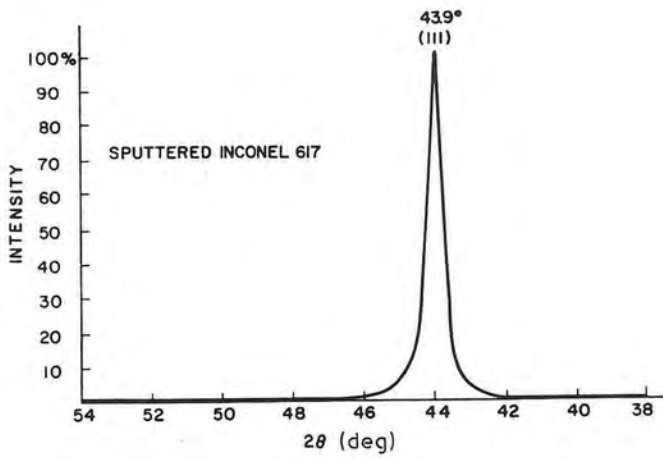
Figure 5 X-ray diffraction pattern of Inconel 617 sputtered on to ground  $\alpha$ -titanium showing only [1 1 1] planes parallel to the substrate.

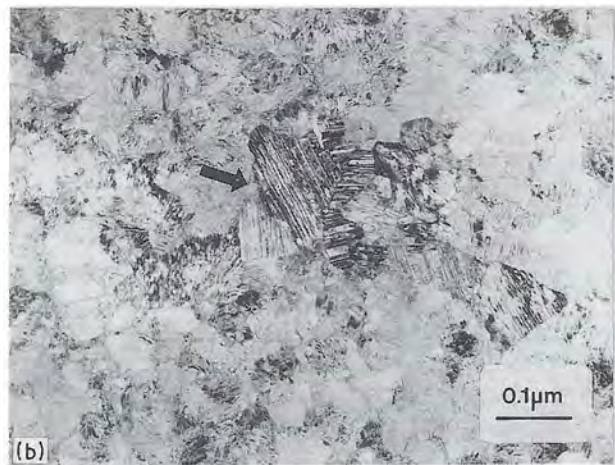
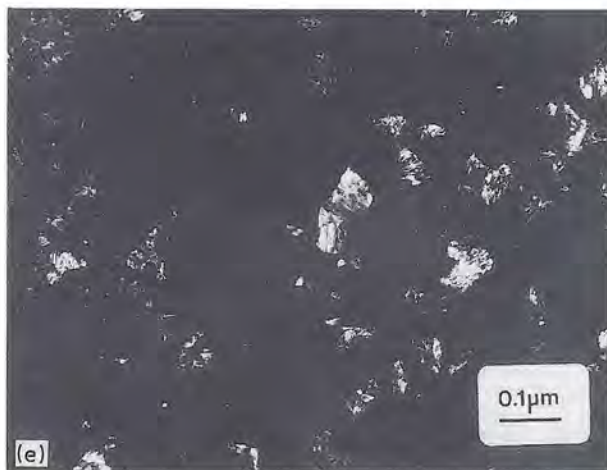
Figure 6 (a) Through-thickness transmission electron micrograph of as-sputtered Inconel 617 deposited on to polished  $\alpha$ -titanium. Grains and grain boundaries are difficult to resolve due to the large amount of strain contrast. (b) Through thickness transmission electron micrograph showing clusters of twins and stacking faults perpendicular to the substrate (arrowed). (c)  $2 \mu\text{m}$  SADP of as-sputtered Inconel 617. Note the diffuse fcc [1 1 1] and [2 0 0] rings, and [2 2 0] preferred orientation. (d) CBED of as-sputtered Inconel 617 showing the fcc [0 1 1] zone axis. (e) [1 1 1] + [2 0 0] dark-field transmission electron micrograph of as-sputtered Inconel 617. (f) [2 2 0] dark-field TEM of as-sputtered Inconel 617. A [2 2 0] preferred orientation is apparent compared to (e).

rings in Fig. 6c are indicative of a large number of grains contributing to the  $2\mu\text{m}$  selected-area diffraction pattern. A (220) preferred orientation is apparent in the SADP (Fig. 6c). Further, the (111) and (200) reflections are thickened and poorly defined due to the lack of (200) crystal orientations and the large amount of strain on (111) extrinsic stacking faults and twin planes, apparently resulting in inconsistent  $d$ -spacings. Higher order reflections (i.e. (400), (333), etc.) appear to be missing, but instead are

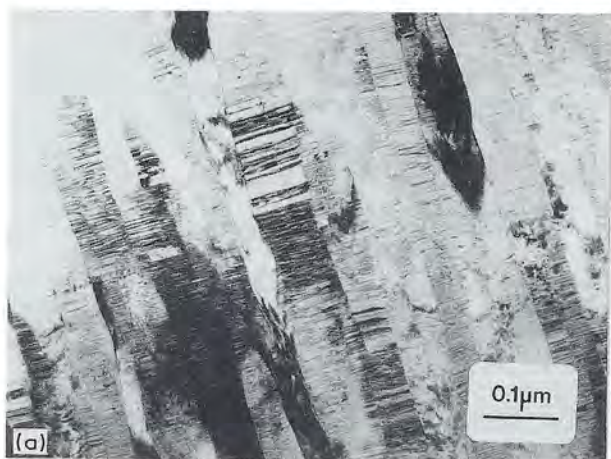
Figure 2 (a) Transmission electron micrograph showing the morphology of columns, twins, and stacking faults in as-sputtered Inconel 617. (b) Higher magnification transmission micrograph illustrating the high density and fineness of planar defects.

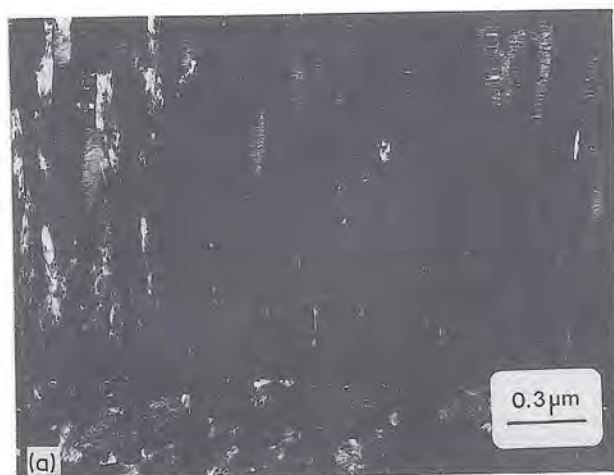
Figure 4 (a) Dark-field transmission electron micrograph of the diffusion spot labelled "A" in Fig. 3. (b) Dark field transmission electron micrograph of the diffraction spot labelled "B" in Fig. 3, showing that streaking is due to  $\{111\}$  planar defects.

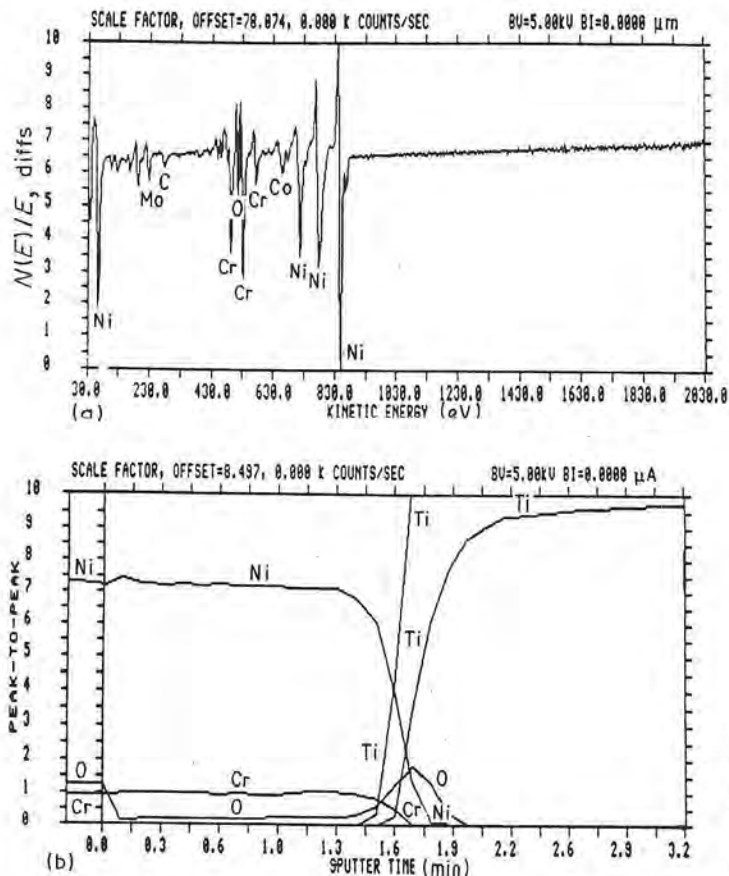
Figure 6 (a) Auger electron spectrum of as-sputtered Inconel 617. The carbon content is commensurate with that expected from sputtering refractory metal carbides in the Inconel 617 target. (b) Auger electron depth profile showing nickel, chromium, titanium and oxygen signals. A sharp Inconel 617/titanium interface is apparent.

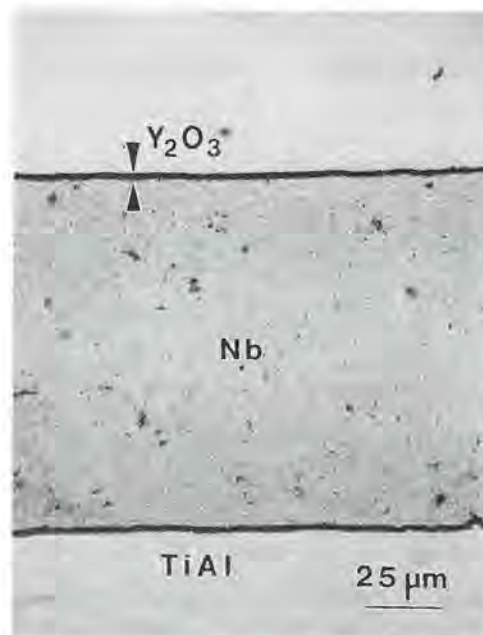
**Fig. 1.** Optical micrograph of composite laminate test specimen after diffusion bonding at 1066°C for 4 h and 10 MPa pressure. Note the absence of reaction products due to the  $\text{Y}_2\text{O}_3$  coating, which remains discrete.

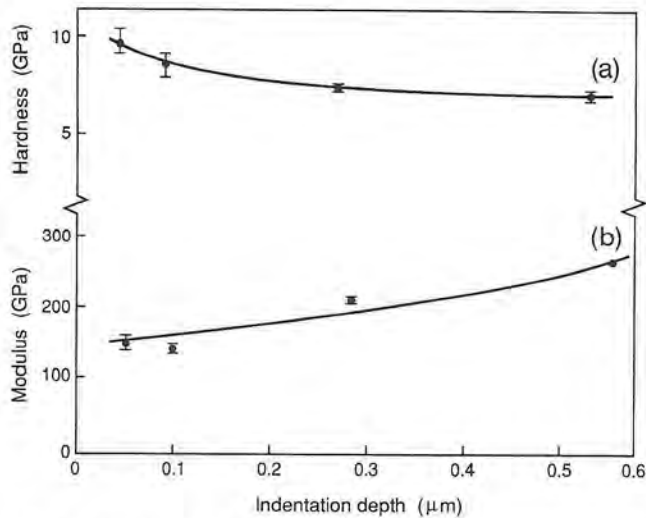
**Fig. 4.** (a) Hardness vs indentation depth as determined by the nanoindentation technique. The hardness for  $\sim 0.5 \mu\text{m}$  deep indentation is 7.5 GPa. Higher hardness at smaller indentation depths is due to the indentation size effect. (b) Elastic modulus of  $\text{Y}_2\text{O}_3$  vs indentation depth. The modulus at small indentation depths (0.05 to 0.1  $\mu\text{m}$ ) is characteristic of bulk  $\text{Y}_2\text{O}_3$ .

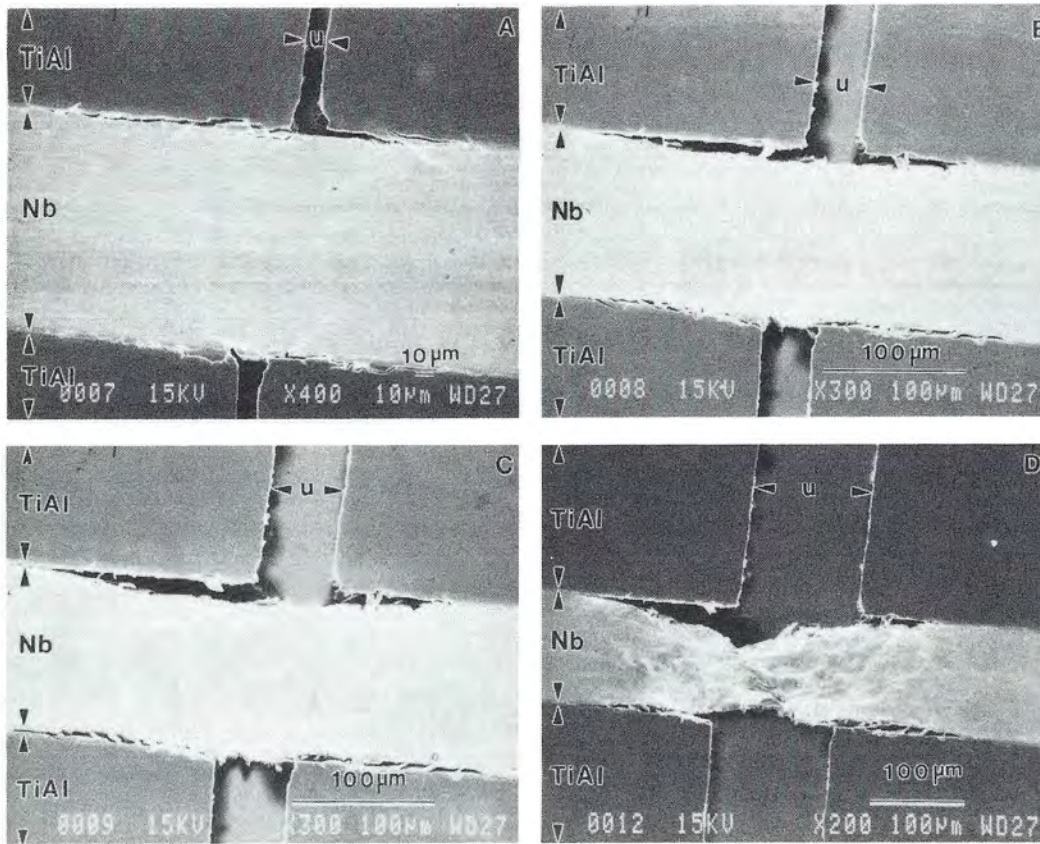
Fig. 7. In situ SEM micrographs of the TiAl-uncoated Nb test specimen. Debonding along the  $\sigma$ -phase is limited, resulting in necking of the niobium at small crack opening displacements. Compare the micrometer markers in Figs. 7 to 9.

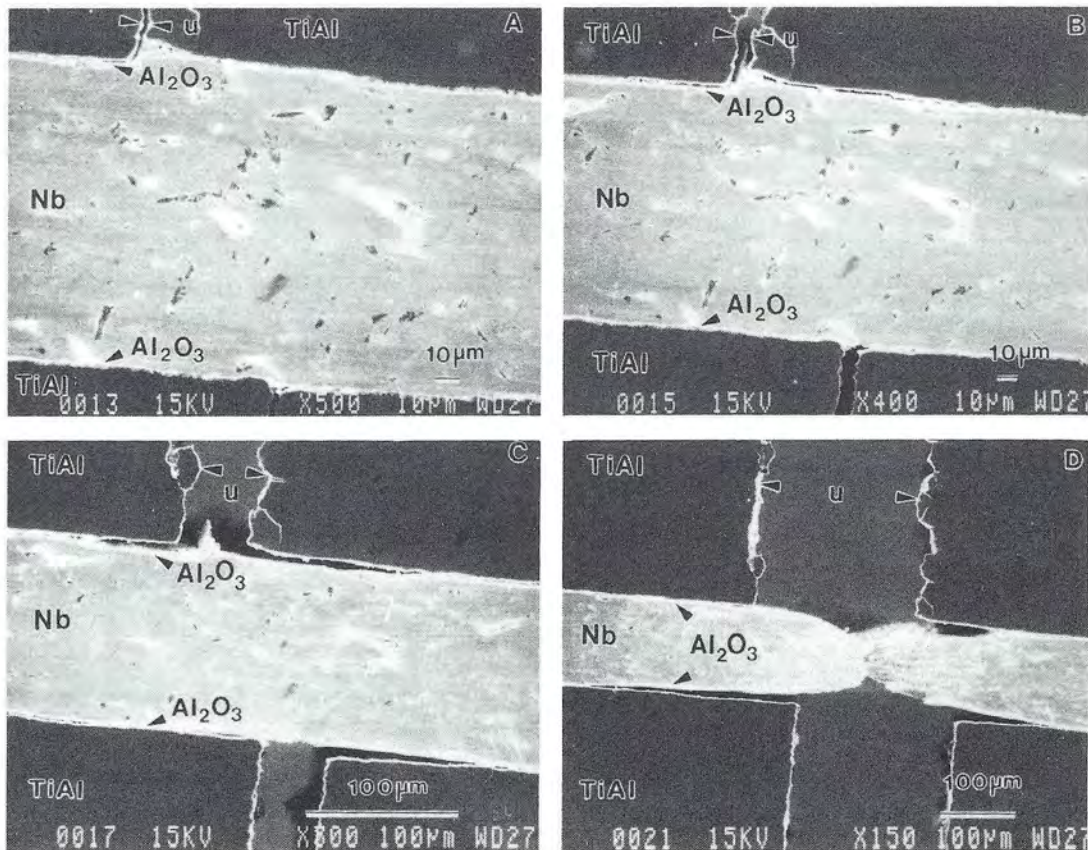
Fig. 8. In situ SEM micrographs of the TiAl-Al<sub>2</sub>O<sub>3</sub> coated Nb test specimen. The debond length and crack opening displacement are larger than in Fig. 7.

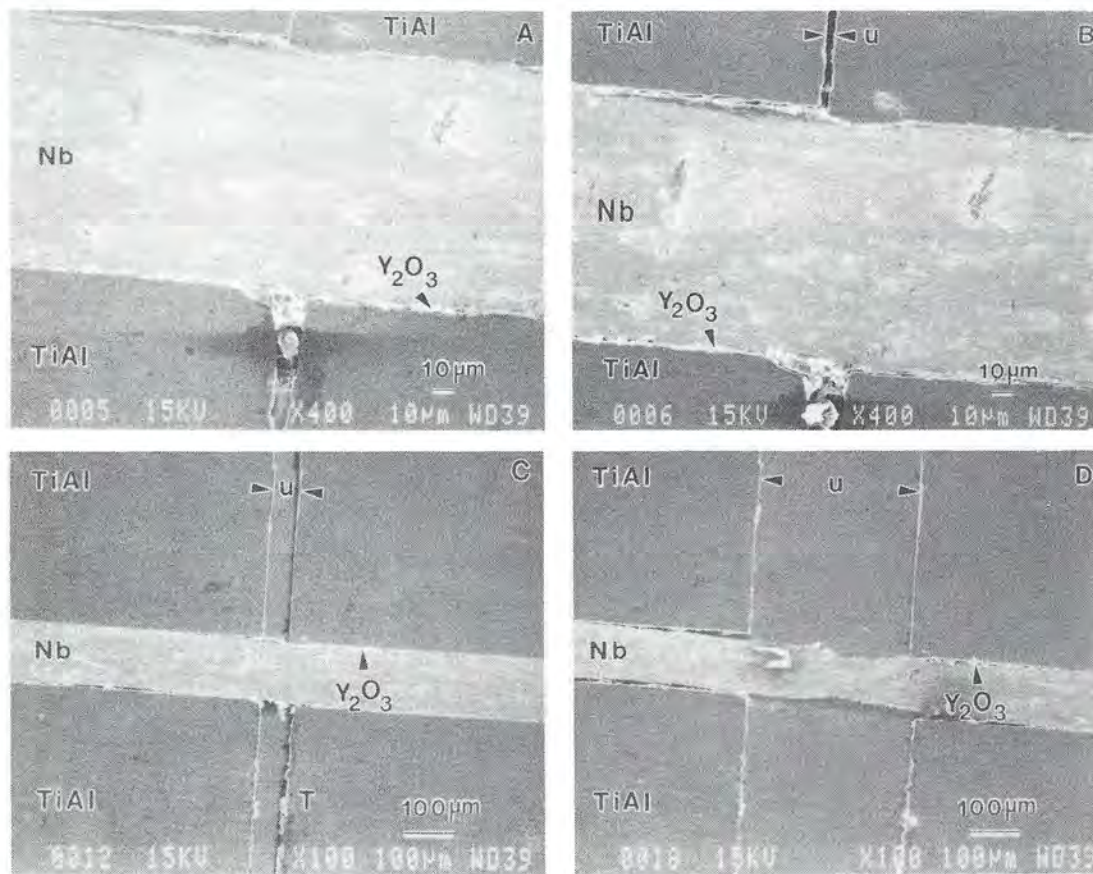
Fig. 9. In situ SEM micrographs of the TiAl- $Y_2O_3$  coated Nb test specimen. Extensive debonding has resulted in a large crack opening displacement.

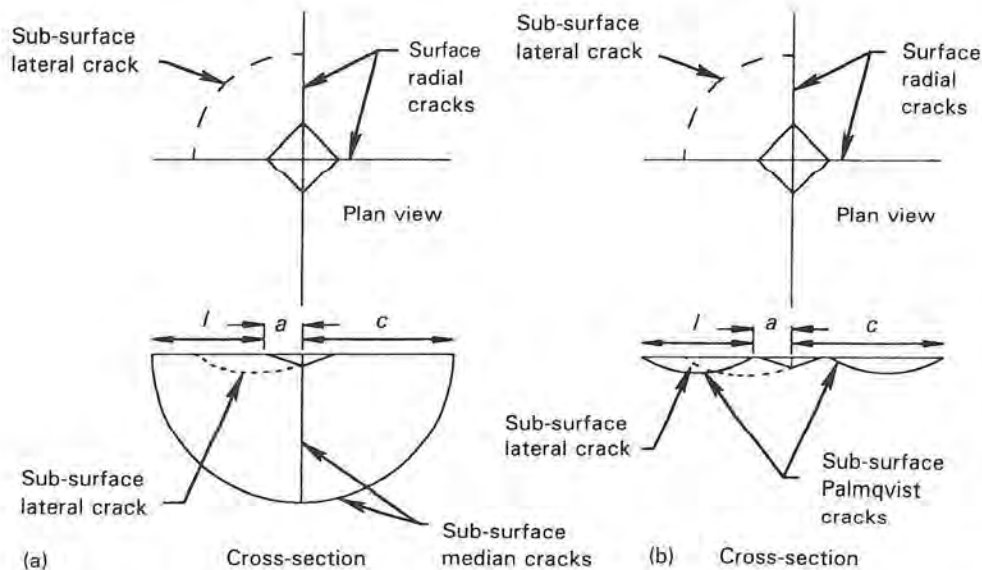
Figure 1 Schematic diagrams of Vickers indentations resulting in the formation of (a) radial–median and (b) Palmqvist cracks [14].

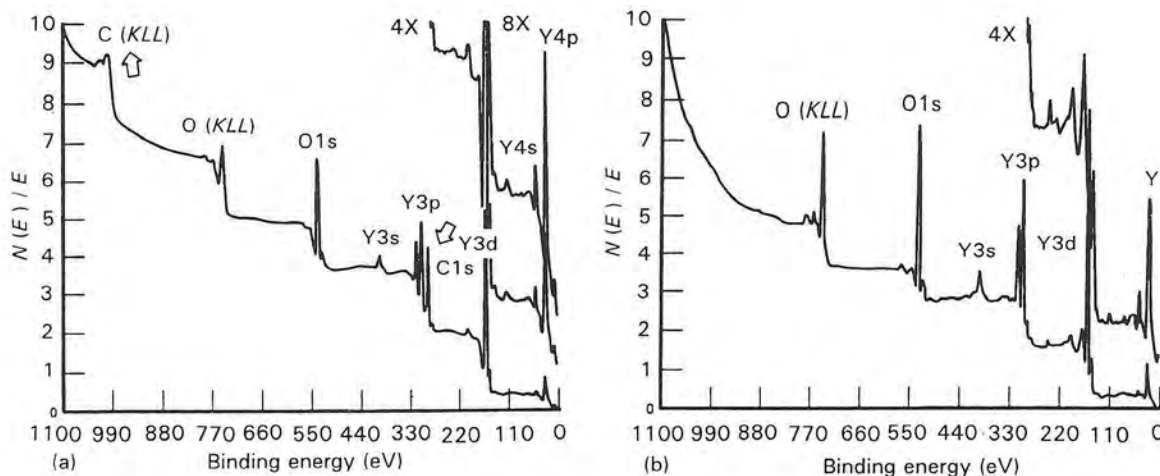
Figure 3 XPS spectra of Y<sub>2</sub>O<sub>3</sub> coating, (a) as-received, and (b) 10 nm below the free surface. The carbon signal is prominent in as-received samples (arrowed), while only yttrium and oxygen are present 10 nm below the free surface.

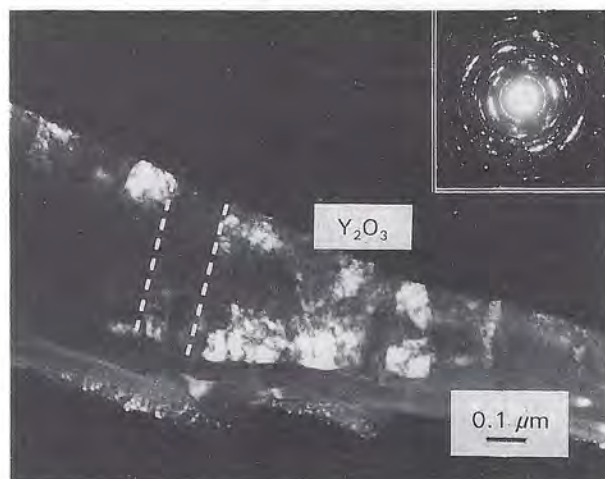
Figure 8 Transmission electron micrograph of a portion of the  $Y_2O_3$  coating and selected-area electron diffraction pattern (inset) from a TiAl/Nb laminate. Note the grains remain columnar after hot-pressing at 1066 °C for 4 h.

occurs. Unfortunately, it could not be observed due to decohesion of the interface. The  $Y_2O_3$ /TiAl interface is more strongly bonded and therefore could be examined by TEM. The most interesting aspect of this interface is the morphology of  $Y_2O_3$  coating (Fig. 8), which has been exposed to 1066 °C for 4 h. The  $Y_2O_3$  coating retains a columnar morphology, with columns  $\sim 0.15$   $\mu m$  wide and extending through the entire thickness of the coating. Reflections from selected-area diffraction patterns contained intense arcs. This, coupled with the shape of individual grains, suggests that the columnar  $Y_2O_3$  grains contain a dense substructure of low-angle grain boundaries that have begun to coalesce. Thus, diffusion bonding resulted in

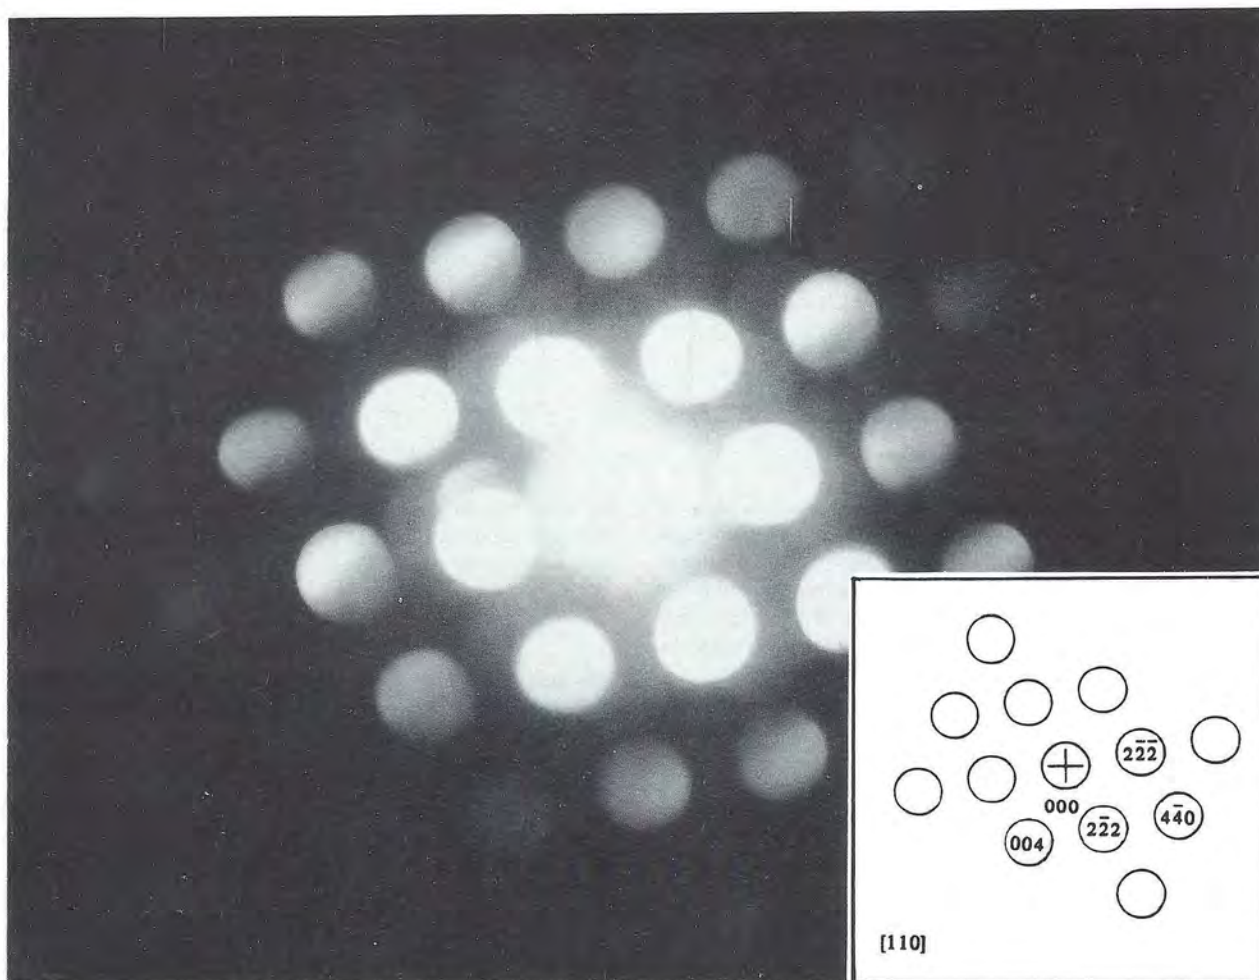
Figure 9 Convergent-beam electron diffraction pattern of  $Y_2O_3$  and corresponding computer-generated [110] zone axis pattern.

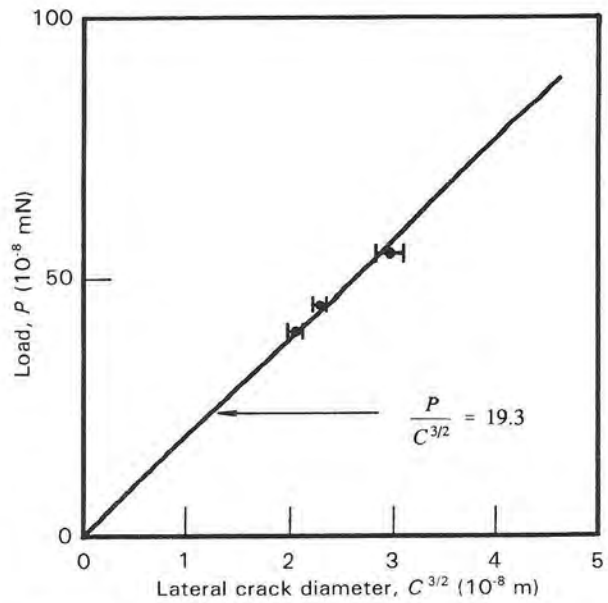
Figure 17 Plot of Vickers indentation load versus radial crack length used to determine the fracture toughness of sputtered  $Y_2O_3$  coatings on sapphire.

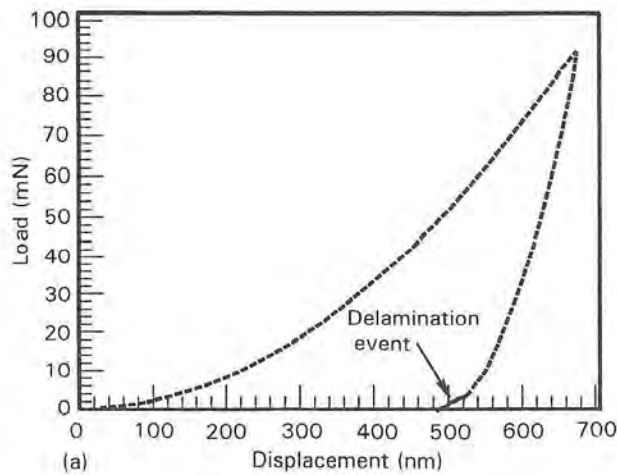
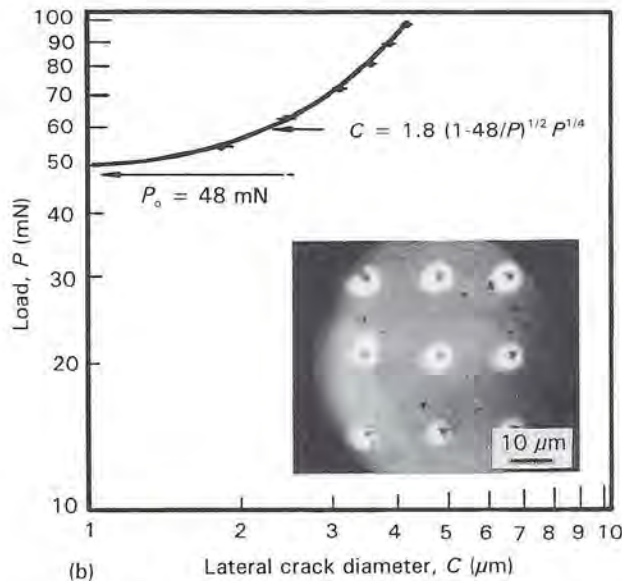
Figure 18 (a) Typical load–displacement curve produced using the Nanoindenter<sup>®</sup>. The coating delamination event is characterized by the change in slope near zero load. (b) Plot of Nanoindenter<sup>®</sup> load versus crack length used to determine  $\text{Y}_2\text{O}_3/\text{Al}_2\text{O}_3$  interfacial toughness and light micrograph of several indentations (inset). Bright areas around indentations are indicative of debonding.

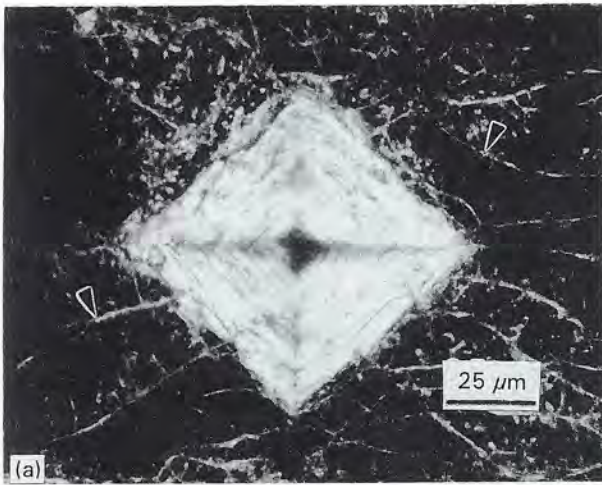
Figure 20 (a) Dark-field optical micrograph of a 9.8 N indentation for  $Y_2O_3$ -coated niobium. Note the numerous cracks emanating from the indentation. (b) Backscattered scanning electron micrograph of a 0.98 N indentation for  $Y_2O_3$  coated niobium. Note the radial and lateral cracks, as well as adherence of the coating to the niobium substrate.

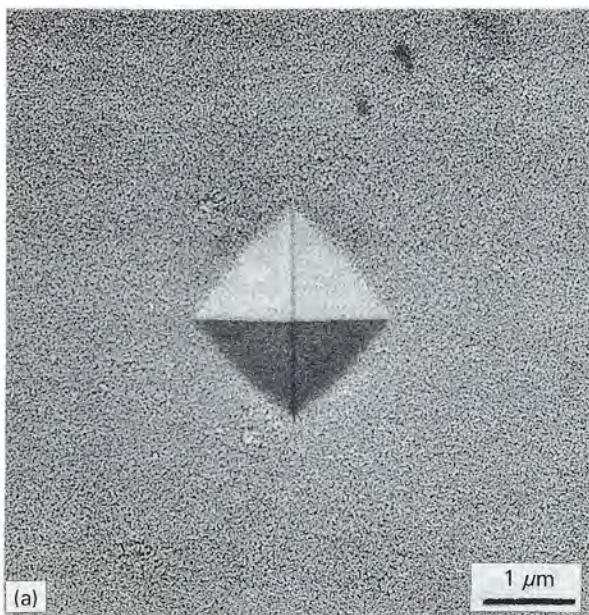
Figure 22 Scanning electron micrographs of indentations produced by loads of (a) 2 N and (b) 10 N showing radial cracks.
