# M.L. "Bob" Emiliani

## PEER-REVIEWED PAPERS

## THE EFFECT OF MICROSTRUCTURE ON THE EROSION OF Ti-6Al-4V BY SPHERICAL PARTICLES AT 90° IMPACT ANGLES

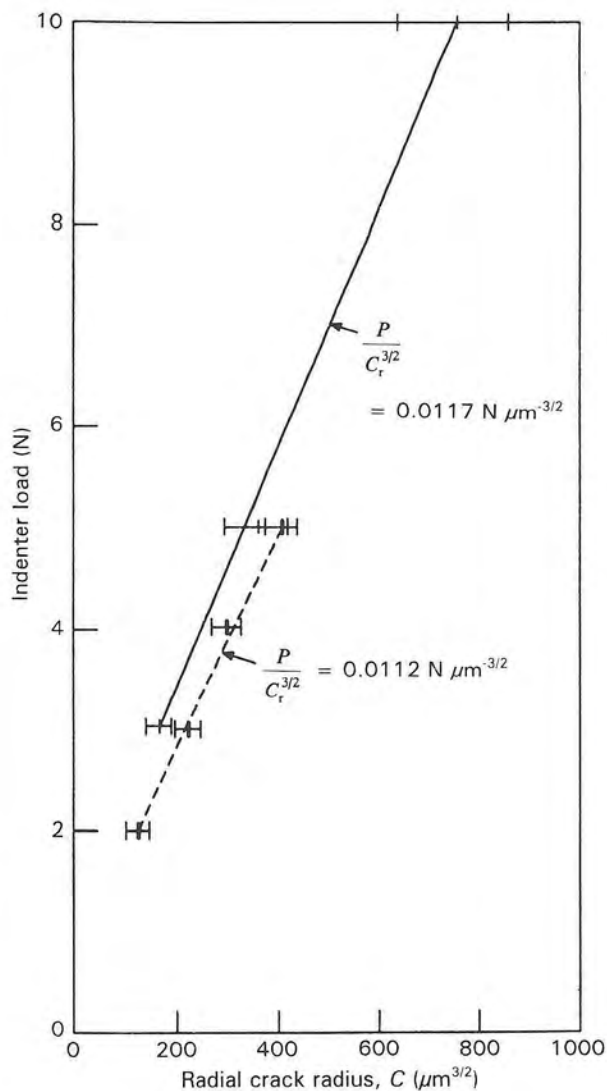
Figure 23 Plots of Vickers indenter load versus radial crack length for the niobium coating. Crack lengths were measured from the top (solid line, Fig. 22) and from the back through the transparent  $Y_2O_3$  wafer, and show good correlation.

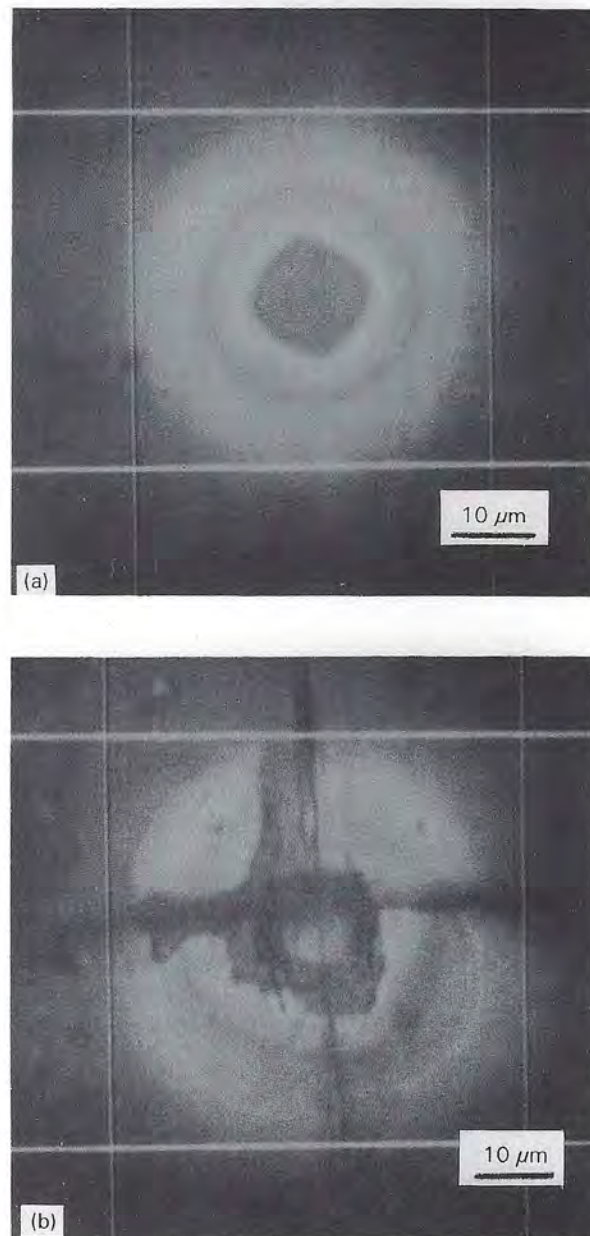
Figure 24 Light micrographs showing debonding of the niobium coating at loads of (a) 1.5 N and (b) 3 N, as viewed from the transparent rear side of the  $Y_2O_3$  wafer. Radial cracks produced by the 3 N load are apparent.

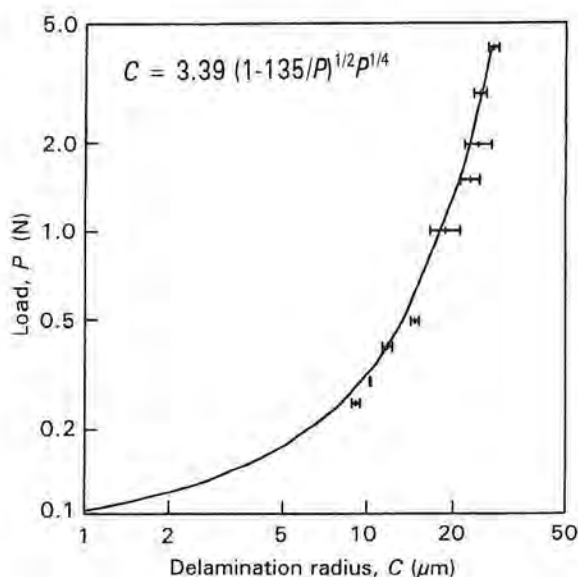
Figure 25 Plot of load versus crack length used to determine Nb/Y<sub>2</sub>O<sub>3</sub> interfacial fracture toughness.

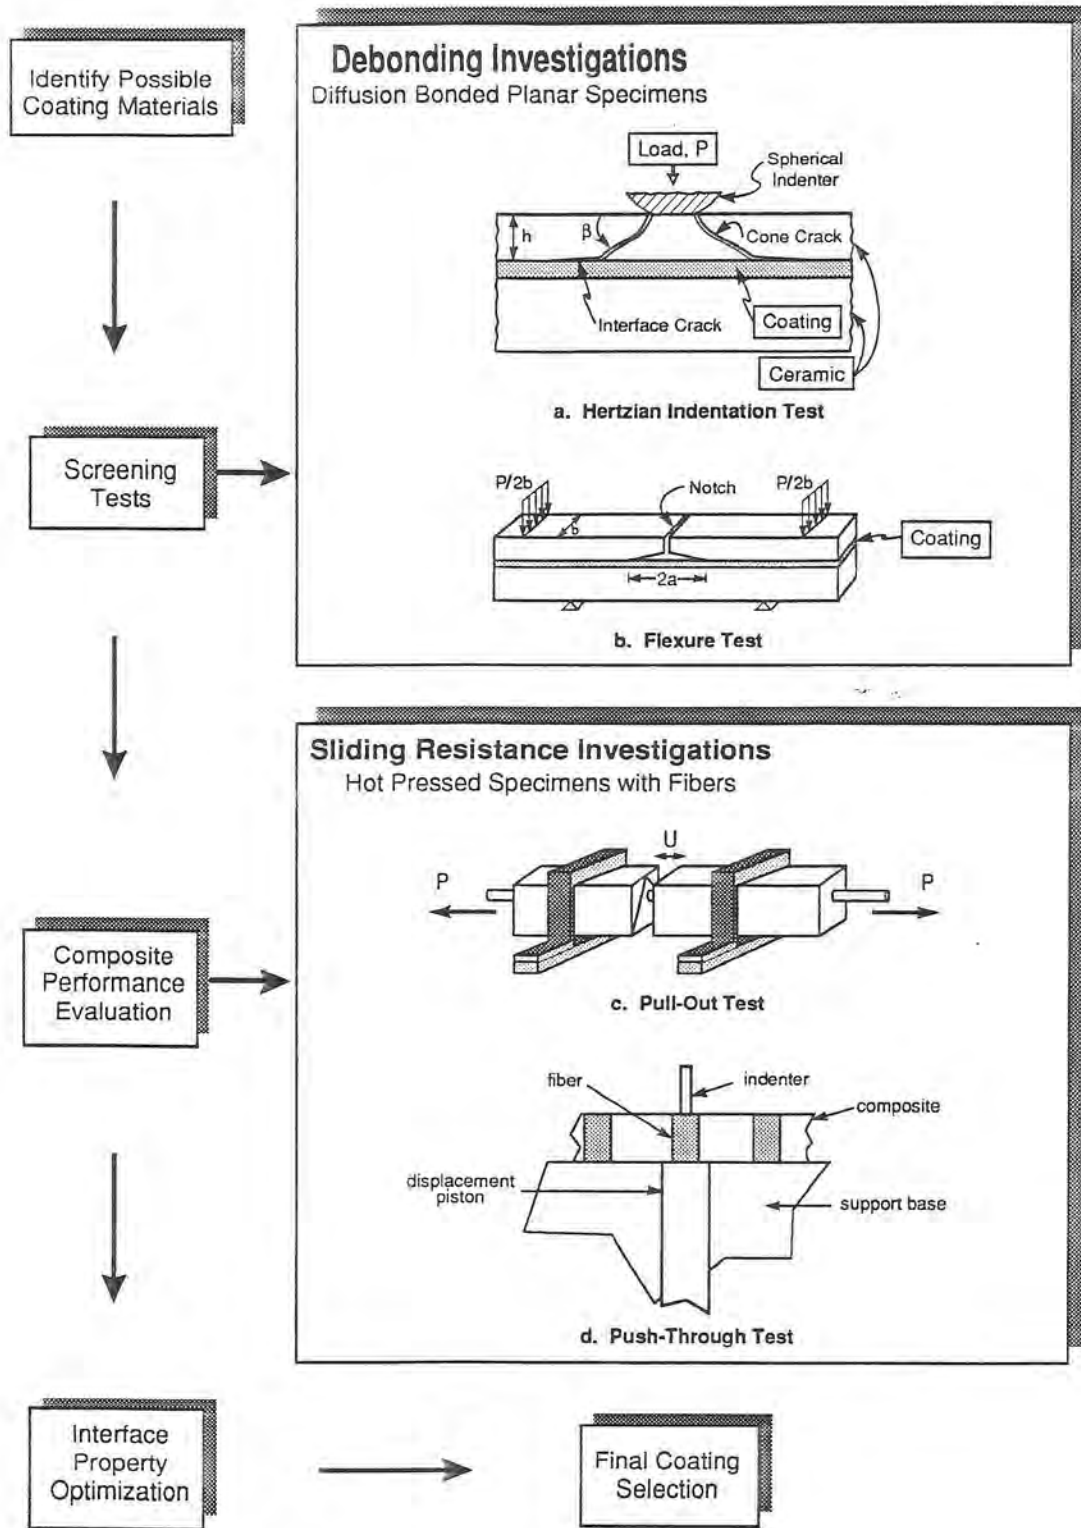
Fig. 1. Approach adopted to identify viable fiber coating concepts for brittle-matrix composites, consisting of developing testing procedures to evaluate the debonding and sliding propensities of various coatings on sapphire.

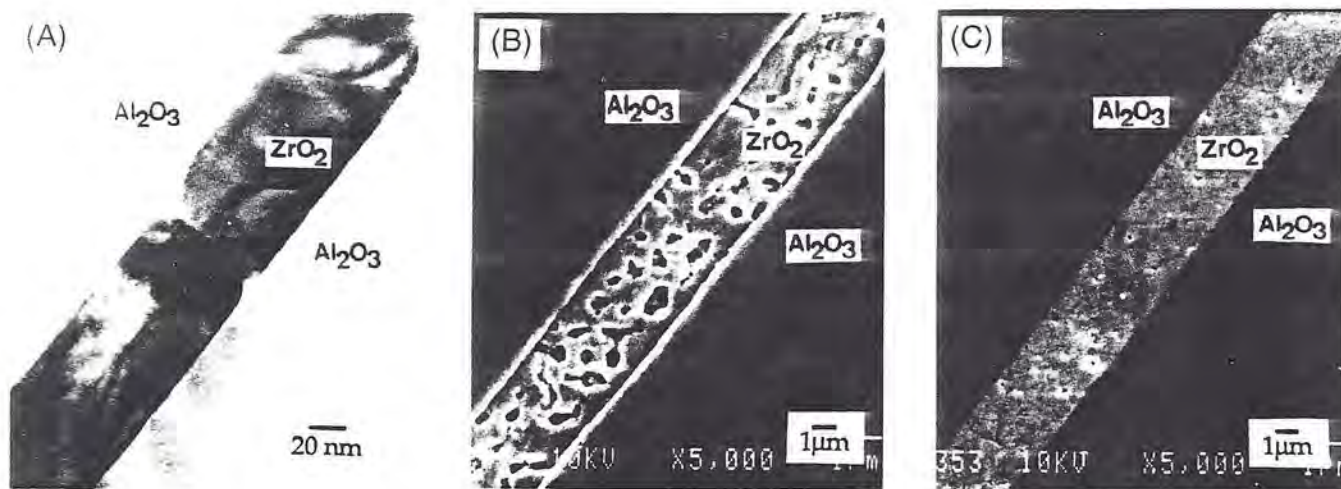
**Fig. 2.** ZrO<sub>2</sub> coating/sapphire interfaces produced by the following diffusion bonding schedules: (A) sol-gel coating diffusion bonded at 1300°C for 12 h with an applied load of ~1 MPa; (B) sputtered coating diffusion bonded at 1300°C for 12 h with an applied load of ~1 MPa; (C) sputtered coating diffusion bonded at 1300°C for 48 h with an applied load of ~3 MPa.

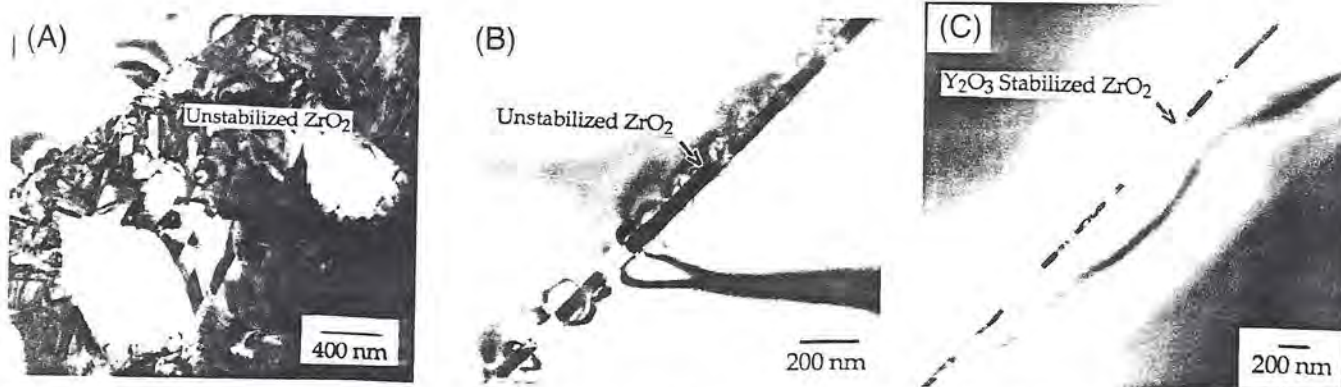
**Fig. 3.** (A) Extensive bend contours in the sapphire when unstabilized ZrO<sub>2</sub> sputtered coatings were used. It is believed that the contours result from strain in the fiber due to the *t* → *m*-ZrO<sub>2</sub> phase transformation. (B) The bend contours in the sapphire decrease with coating thickness for the unstabilized sol-gel ZrO<sub>2</sub> coating. (C) The extent of bend contours was further reduced when thin stabilized sol-gel ZrO<sub>2</sub> coatings were used. The remaining stresses are believed to result from CTE mismatch across the well-bonded interface.

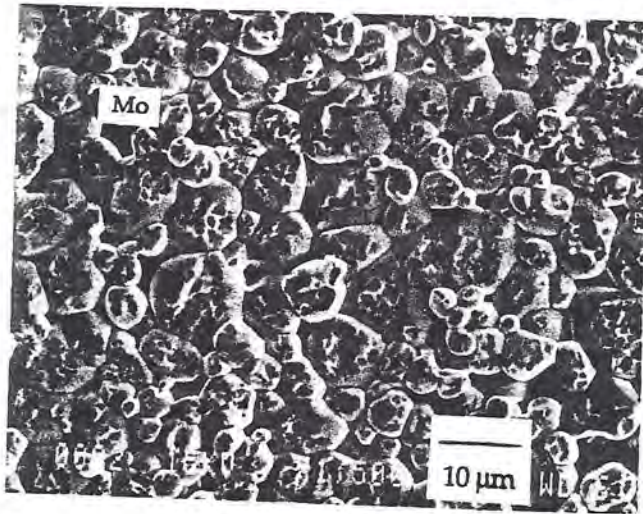
Fig. 6. Mo coating conforming to the surface features of a high-purity polycrystalline  $\text{Al}_2\text{O}_3$  substrate during diffusion bonding.

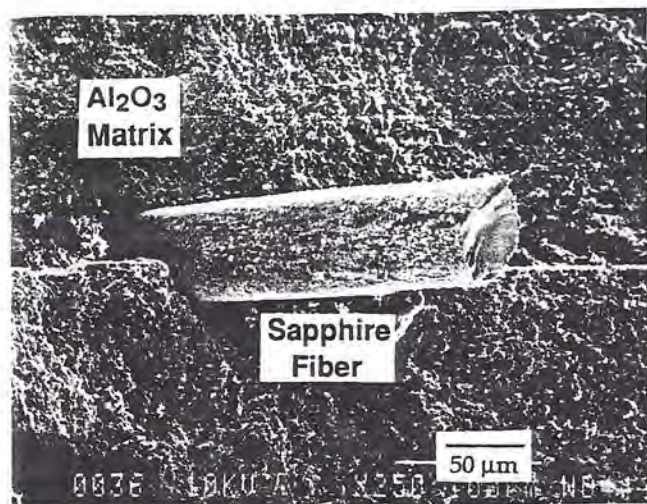
Fig. 9. A porous oxide interface led to fiber pull-out of a few fiber diameters. Oxide particles were observed to sinter to the sapphire fiber and remained attached during pull-out. The fracture mirror on the fiber is also visible.

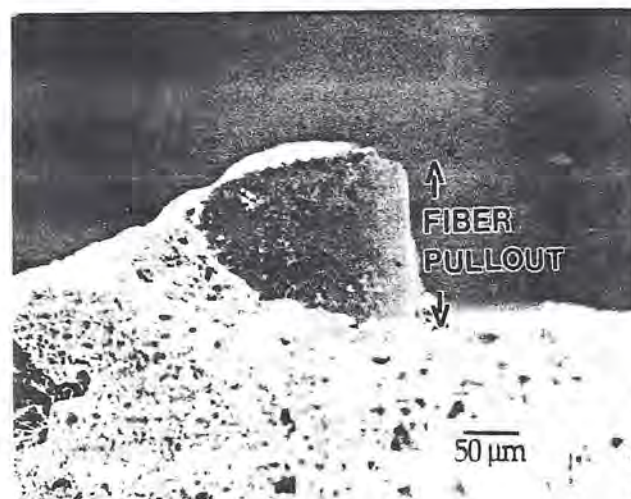
Fig. 10. Short fiber pull-out lengths were observed when Mo coatings were used.

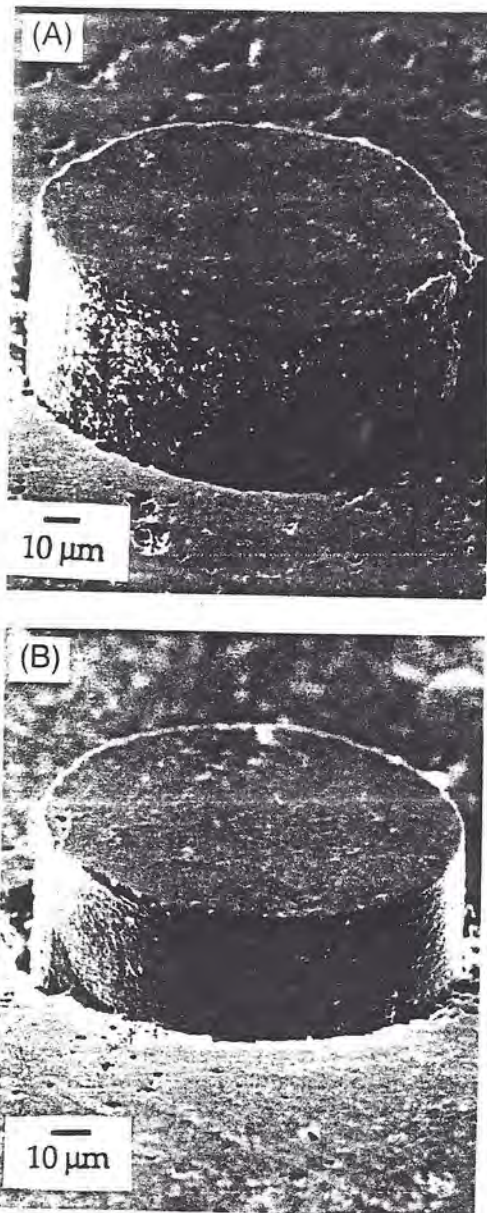
Fig. 11. The surface morphology of the pushed-out sapphire fibers was found to change when the Mo coating was removed by oxidation: (A) as-hot-pressed condition; (B) heat-treated condition.

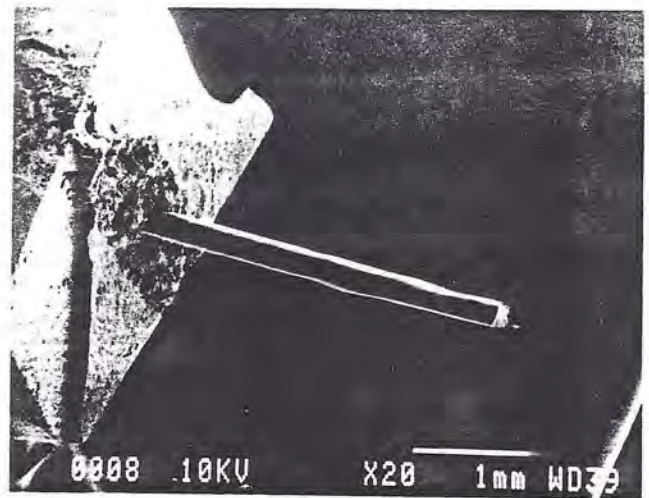
Fig. 12. Long fiber pull-out can result when thick ( $\sim 6 \mu\text{m}$ ) Mo coatings are removed by oxidation.

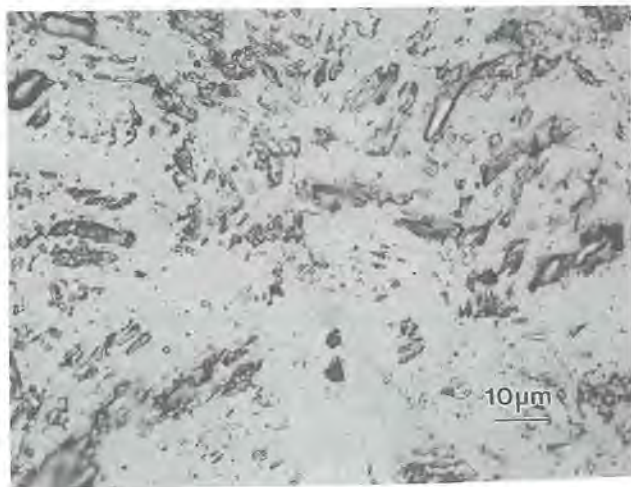
Fig. 1. Light micrograph of polished hot-pressed  $\text{CrB}_2$ . Pull-out appears as acicular regions. Porosity is not evident in this micrograph.

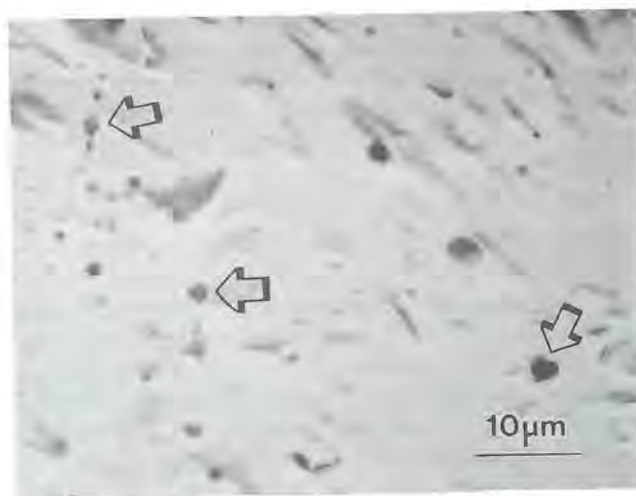
Fig. 2. SEM image of polished hot-pressed  $\text{CrB}_2$ . Dark areas (arrows) were identified by EDS as aluminosilicate inclusions.

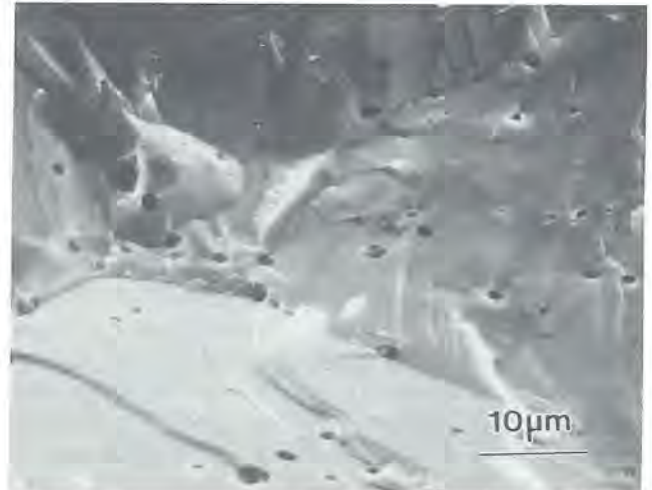
Fig. 4. Fractograph of  $\text{CrB}_2$  showing failure by cleavage. Unconnected porosity and  $\text{AlSi}_x\text{O}_y$  inclusions are apparent. The grain size is  $20\text{--}30 \mu\text{m}$ . The density of hot-pressed  $\text{CrB}_2$  is approximately 88% of theoretical.

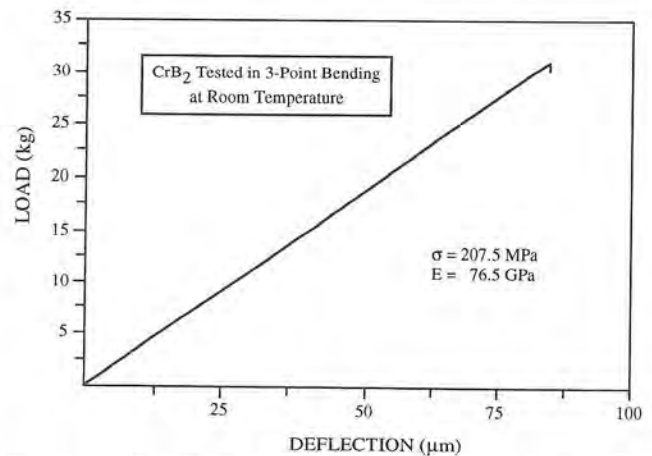
Fig. 5. Load-deflection curve for hot-pressed  $\text{CrB}_2$  tested in three-point bending at room temperature.

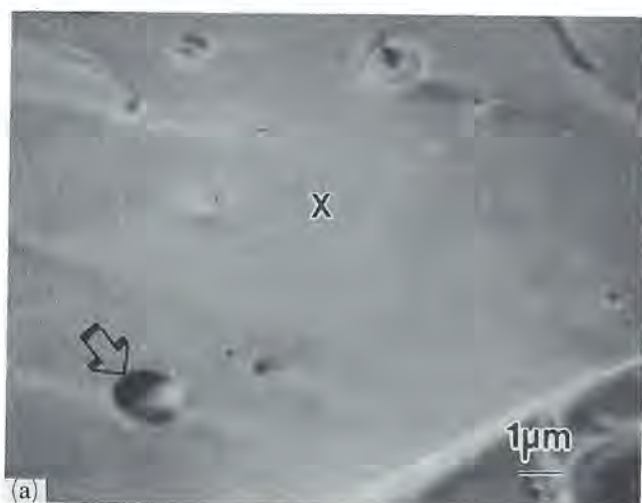
Fig. 9. (a) SEM image of the fracture surface of hot-pressed  $\text{CrB}_2$ . The location of the Auger analysis is labeled X. Note the aluminosilicate inclusion (arrow). (b) Auger spectrum of a fracture surface of hot-pressed  $\text{CrB}_2$  after sputtering to approximately 300 nm below the free surface. Only Cr, B and C are detected.

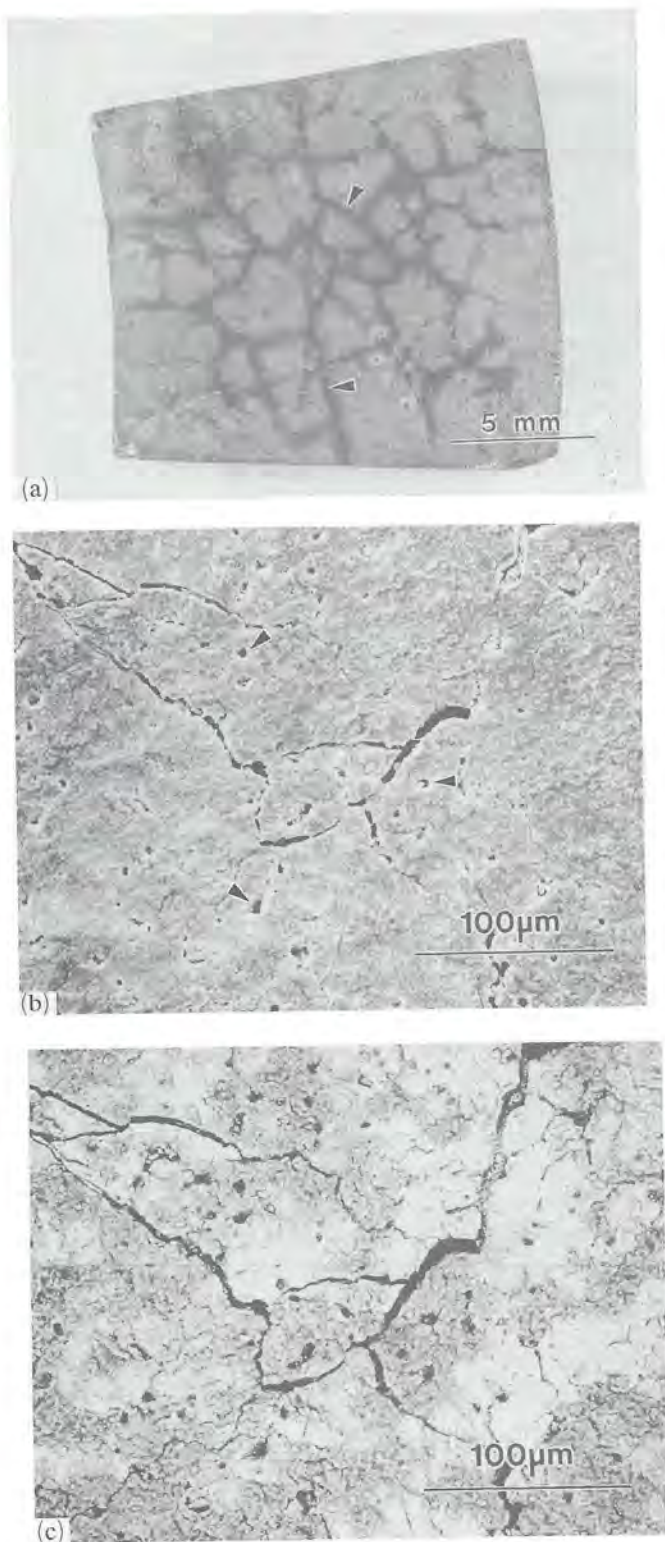
Fig. 10. (a) Photomicrograph of hot-pressed  $\text{CrB}_2$  water quenched from  $1100^\circ\text{C}$ . The coupon remained in a single piece despite containing extensive cracks (arrows). (b) Secondary electron micrograph of cracks in hot-pressed  $\text{CrB}_2$  water quenched from  $1100^\circ\text{C}$ . Note the pores in the surface characteristic of those found in hot-pressed  $\text{CrB}_2$  (arrows). (c) Back-scattered electron micrograph of cracks in hot-pressed  $\text{CrB}_2$  water quenched from  $1100^\circ\text{C}$ . The dark areas are rich in O or B.

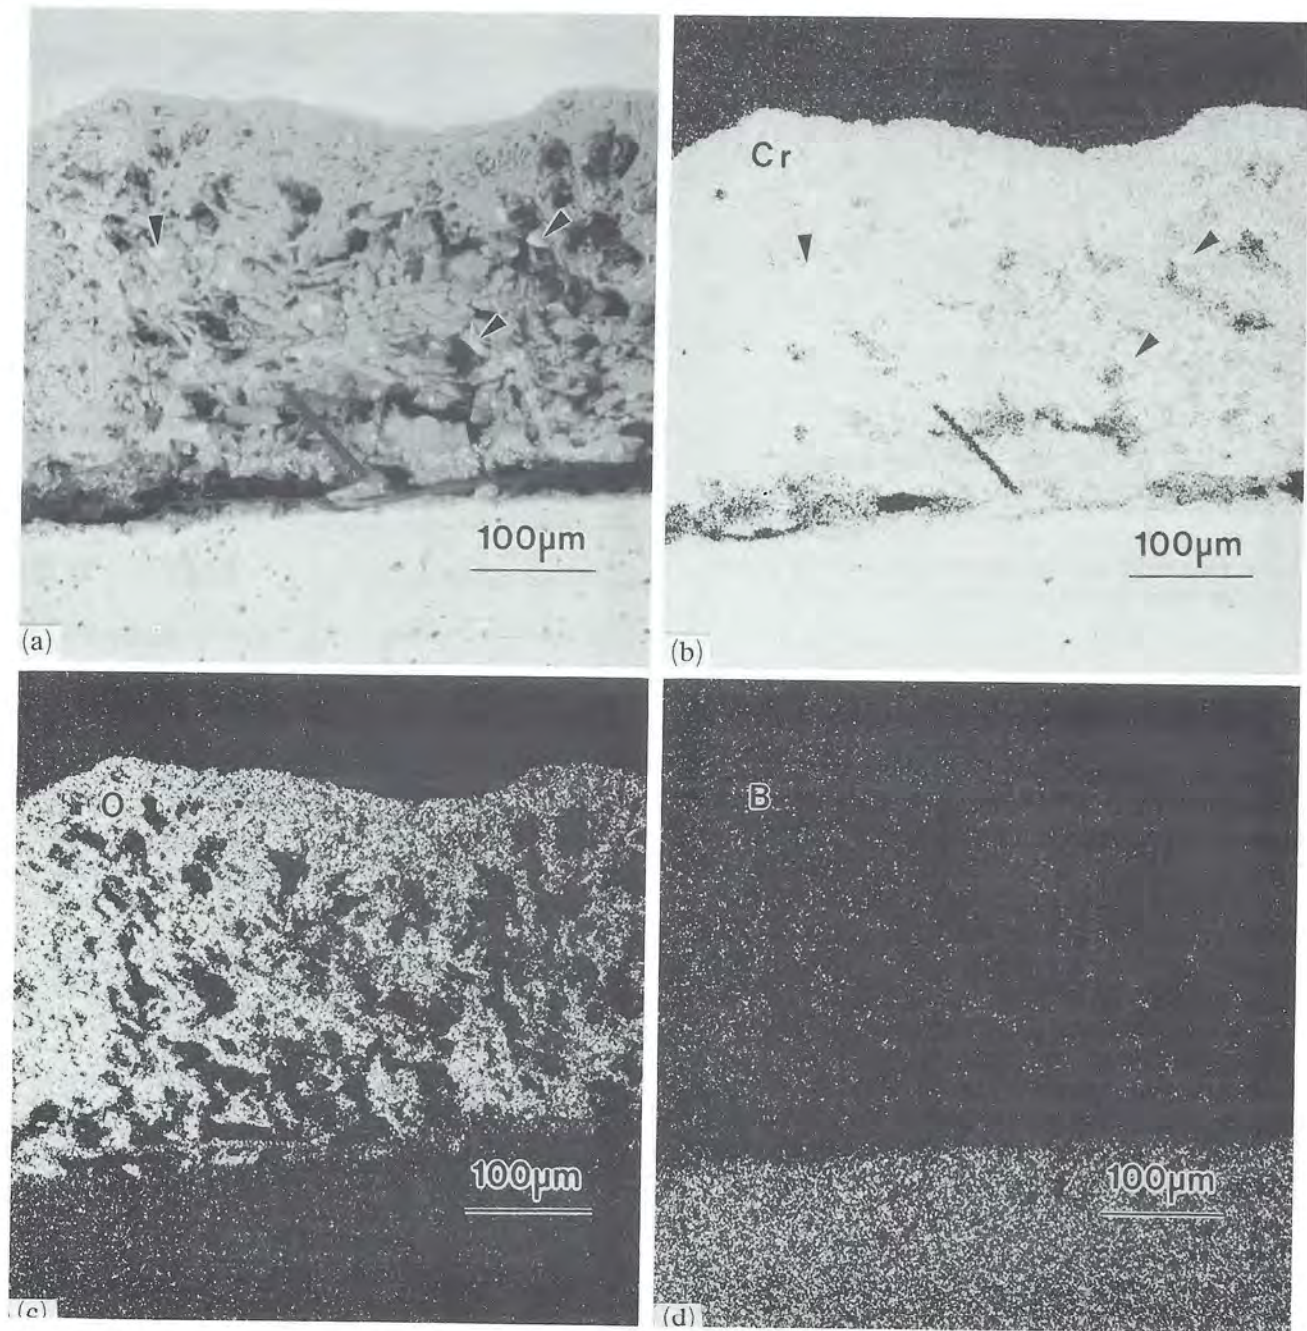
Fig. 14. SEM images of  $\text{CrB}_2$  oxidized in static furnace air at  $1100^\circ\text{C}$ : (a) the area mapped, (b) Cr X-ray map, (c) O X-ray map, and (d) B X-ray map. The arrows in (a) and (b) correspond to Cr-rich particles present in the oxidation product. The oxidation product and diboride are not deficient in B as part (d) indicates.

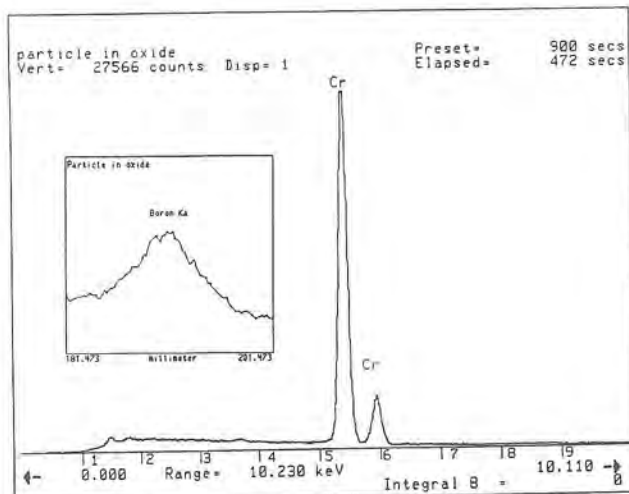
Fig. 15. Energy dispersive and wavelength dispersive (inset) spectra of the Cr-rich particles found in the oxidation product (Fig. 14(a) or 14(b)). The particles contain only Cr and B.

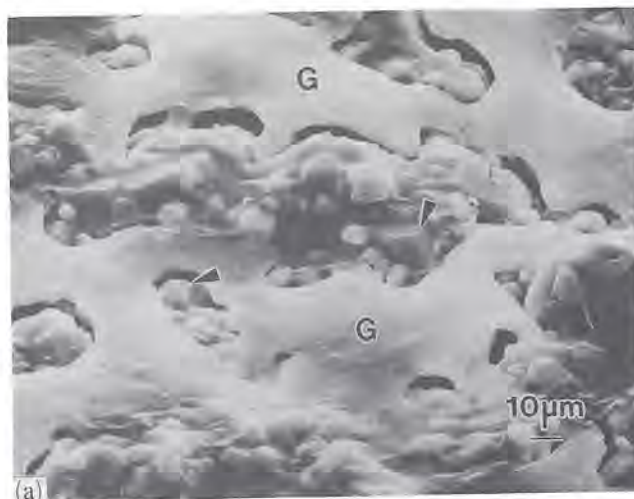
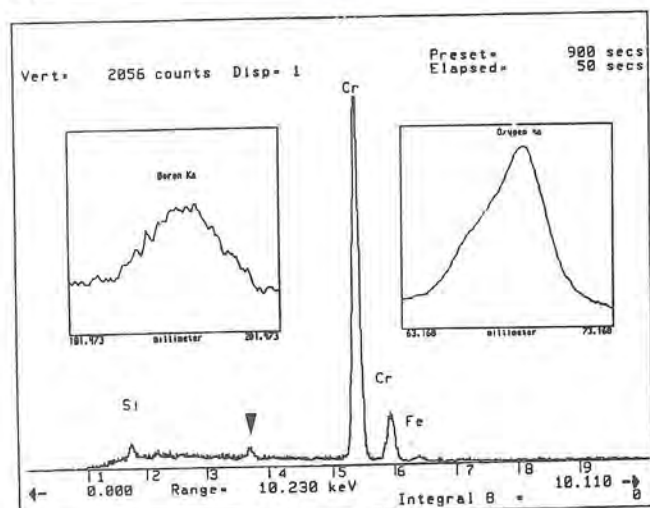
(b) Fig. 16. (a) SEM image of the surface of the massive oxidation product shown in Fig. 11(a). It contains small faceted particles (arrows) and a glassy phase (labeled G). (b) Energy dispersive and wavelength dispersive (insets) spectra of the oxidation product shown in (a). The oxide contains primarily Cr, B and O with small amounts of silicon and iron. The latter two elements are segregated impurities previously found in hot-pressed  $\text{CrB}_2$  (Fig. 3(a)). The small peak between Si and Cr (arrow) is the Cr escape peak.

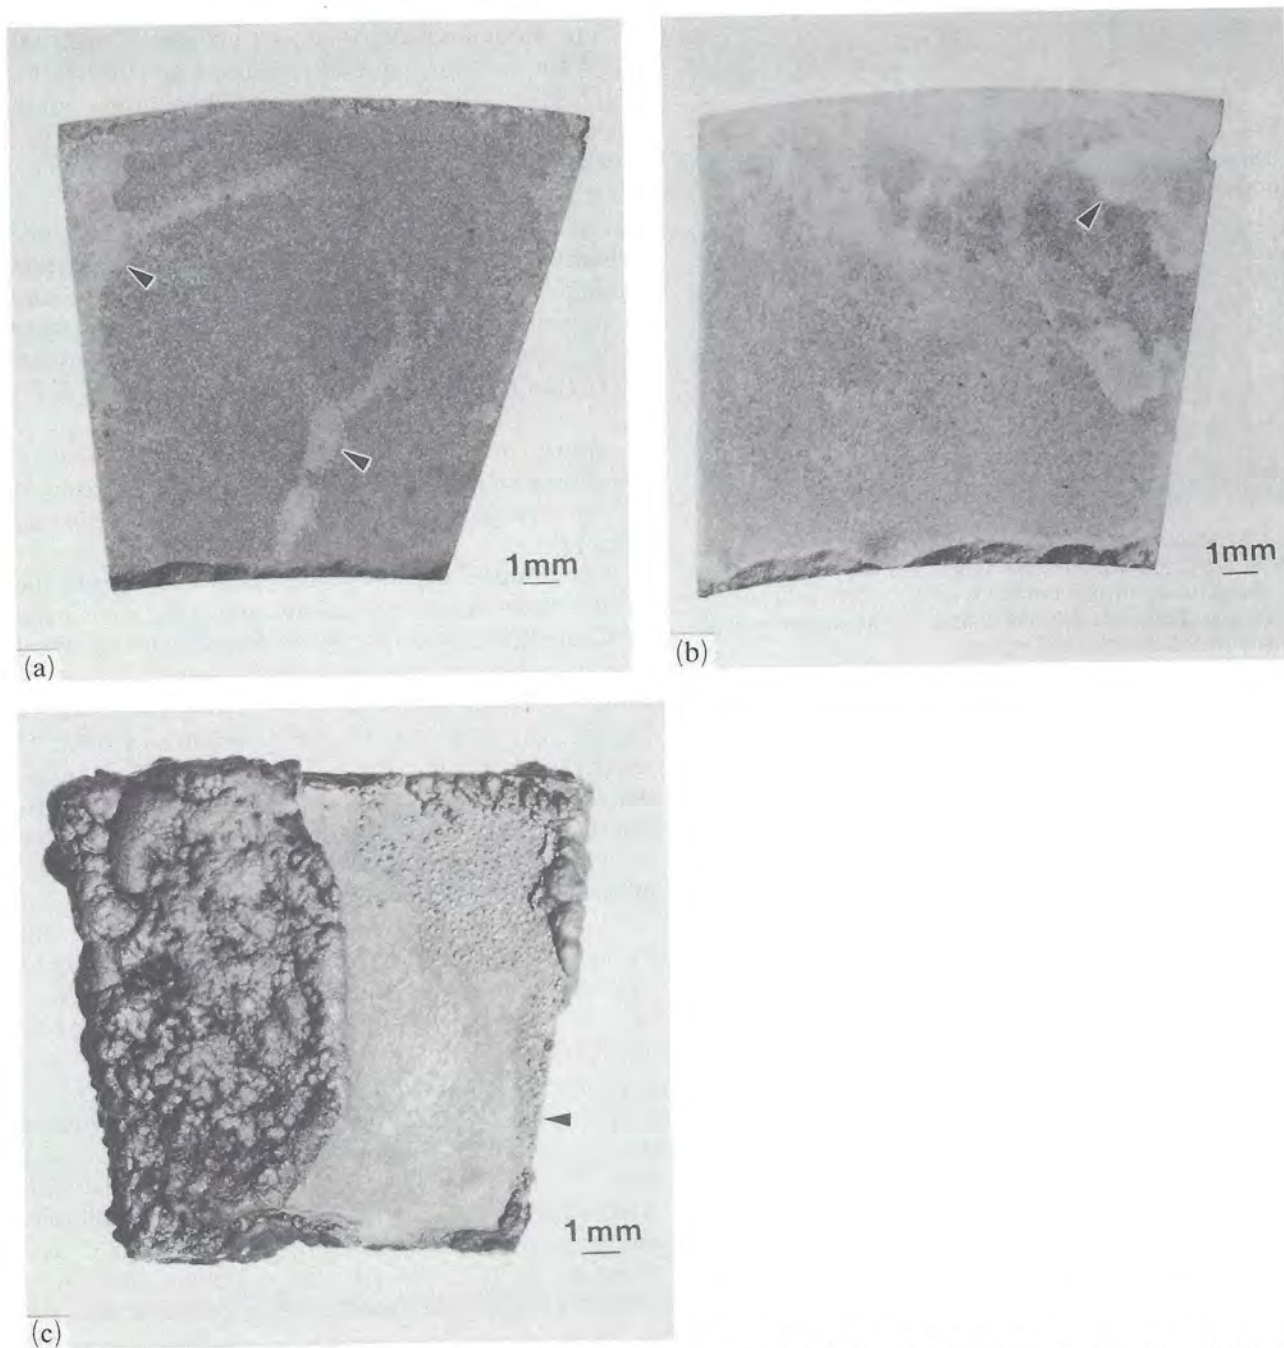
Fig. 19. Photomicrographs of  $\text{CrB}_2$  cyclic oxidation samples: (a) 700 °C, (b) 900 °C, and (c) 1100 °C coupons. Note the discolored regions in samples oxidized at 700 °C and 900 °C (arrows). The presence of a large area free of massive oxidation product (arrow in part (c)) is similar to that found in hot-pressed  $\text{CrB}_2$  oxidized in static air at 1100 °C for 100 h.
